NATIONAL ADVISORY COMMITTEE FOR AERONAUTICS

ADVANCE CONFIDENTIAL REPORT

MEASUREMENTS OF THE FLYING QUALITIES OF A
SUPERMARINE SPITFIRE VA AIRPLANE

By William H. Phillips and Joseph R. Vensel

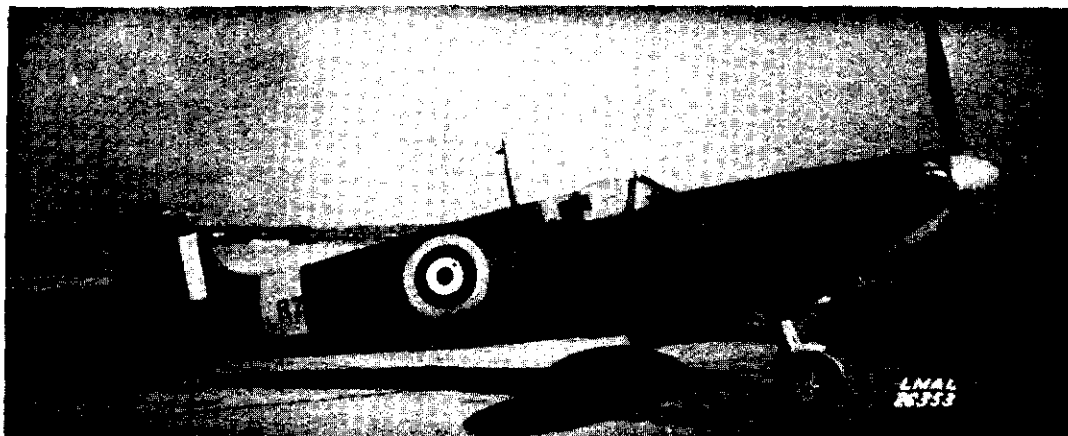
Figure 1.- Side view of the Supermarine Spitfire airplane.

The Supermarine Spitfire is a single-place, single-engine, low-wing, cantilever monoplane with retractable landing gear and partial-span split flaps (figs. 1, 2, 3, and 4). The general specifications of the airplane are as follows:

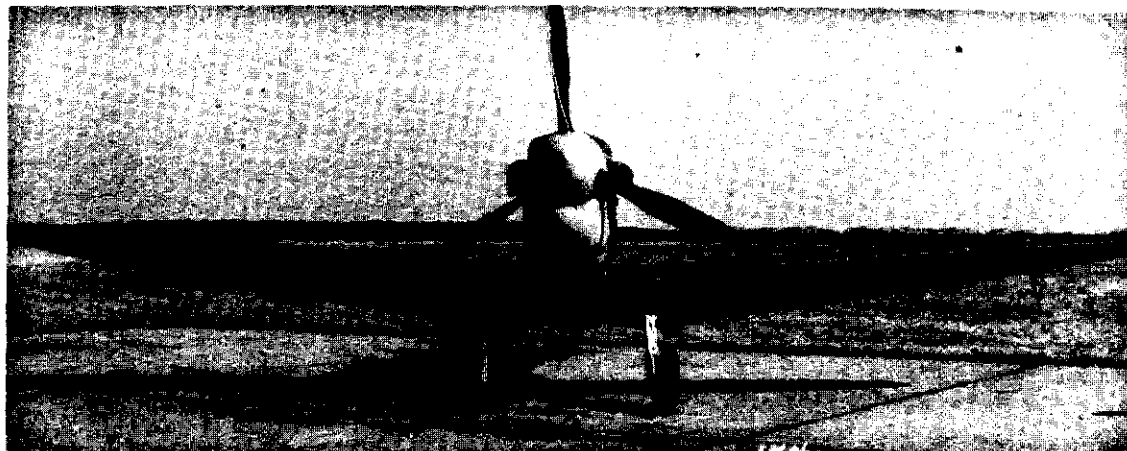
Figure 2.- Front view of the Supermarine Spitfire airplane.

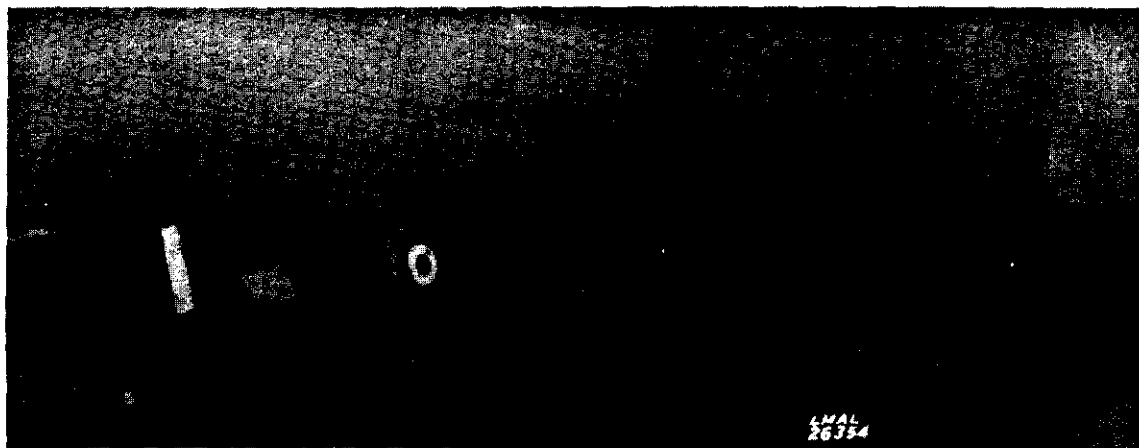
Figure 3.- Three-quarter rear view of the Supermarine airplane.

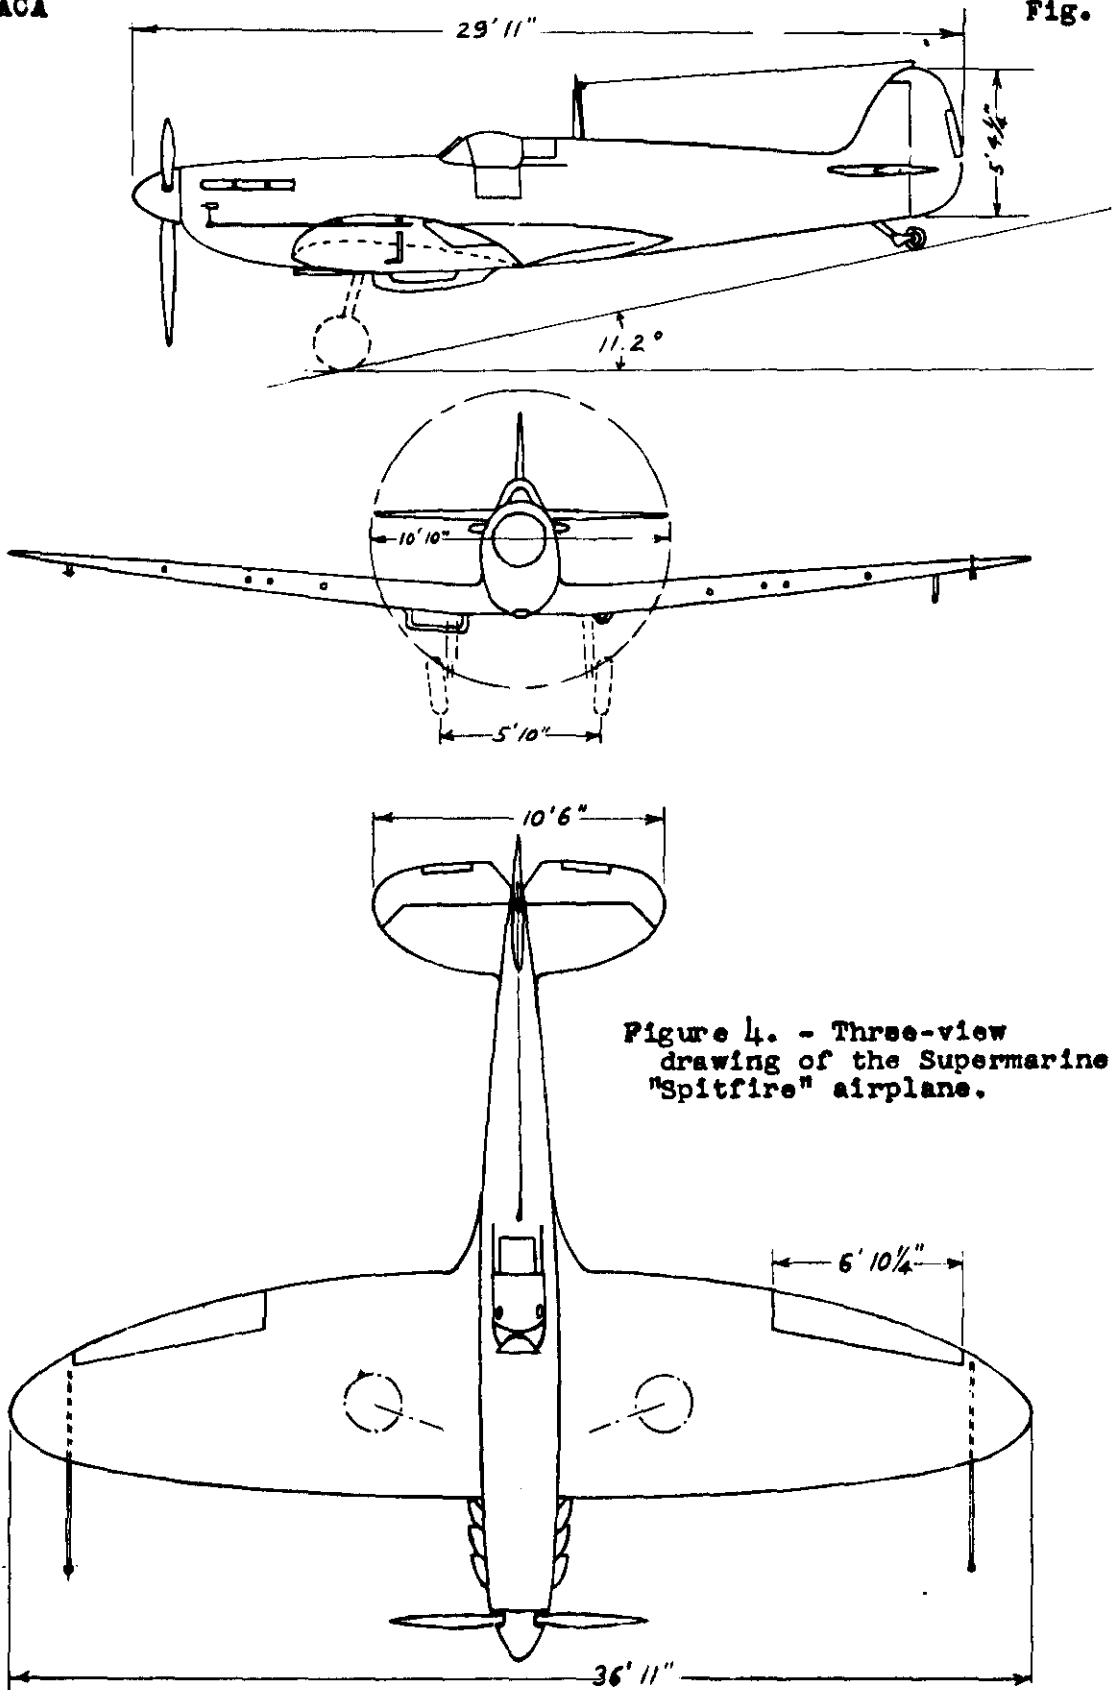
Fig. 4

Figure 4. - Three-view drawing of the Supermarine "Spitfire" airplane.

ahead of the right wing tip. The yaw vane was located at the end of a similar boom on the left wing tip, as shown on figure 4. It was believed that angularity of the flow at this point might cause some error in the recorded sideslip angles. For this reason, another recorder was mounted on the right wing tip and the angles of the two yaw vanes were recorded simultaneously in flight throughout the speed range under various flap and power conditions. Because of symmetry of the airplane, one-half the difference between the readings of the two yaw vanes was taken to represent the correction to apply to each yaw vane. This correction has been applied to all of the recorded values of sideslip angle. These values are therefore believed to represent the actual angles of sideslip of the thrust axis. The difference between the readings of the two yaw vanes was about 3° with level flight power and 2° with power off. The vanes showed the flow to be converging toward the fuselage.

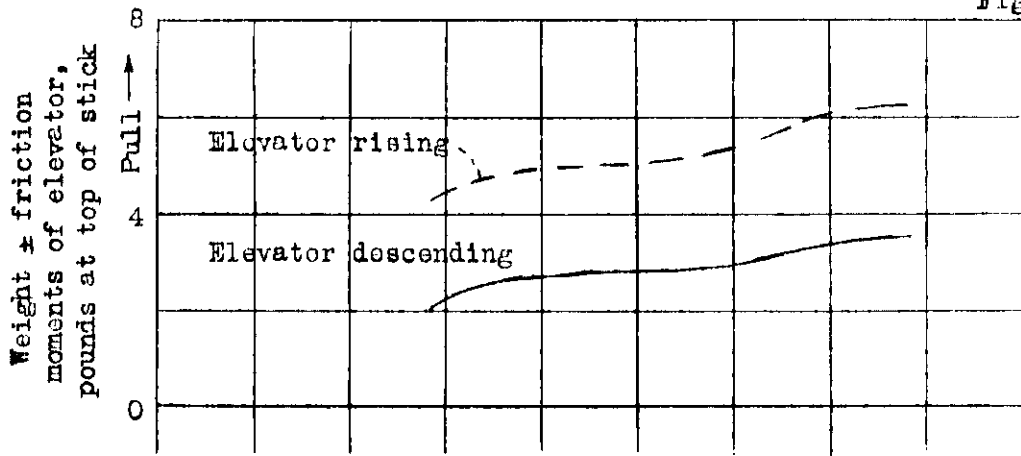
Figure 5.- Variation with control-stick angle of elevator angle and stick force caused by elevator friction and unbalance. Supermarine Spitfire airplane.

3. The friction in the elevator system was such that a force of 2 pounds was required to reverse the motion of the stick, as shown in figure 5. This friction was small enough that, in the flight conditions where a stable stick-force gradient existed, the control would return to its trim position.

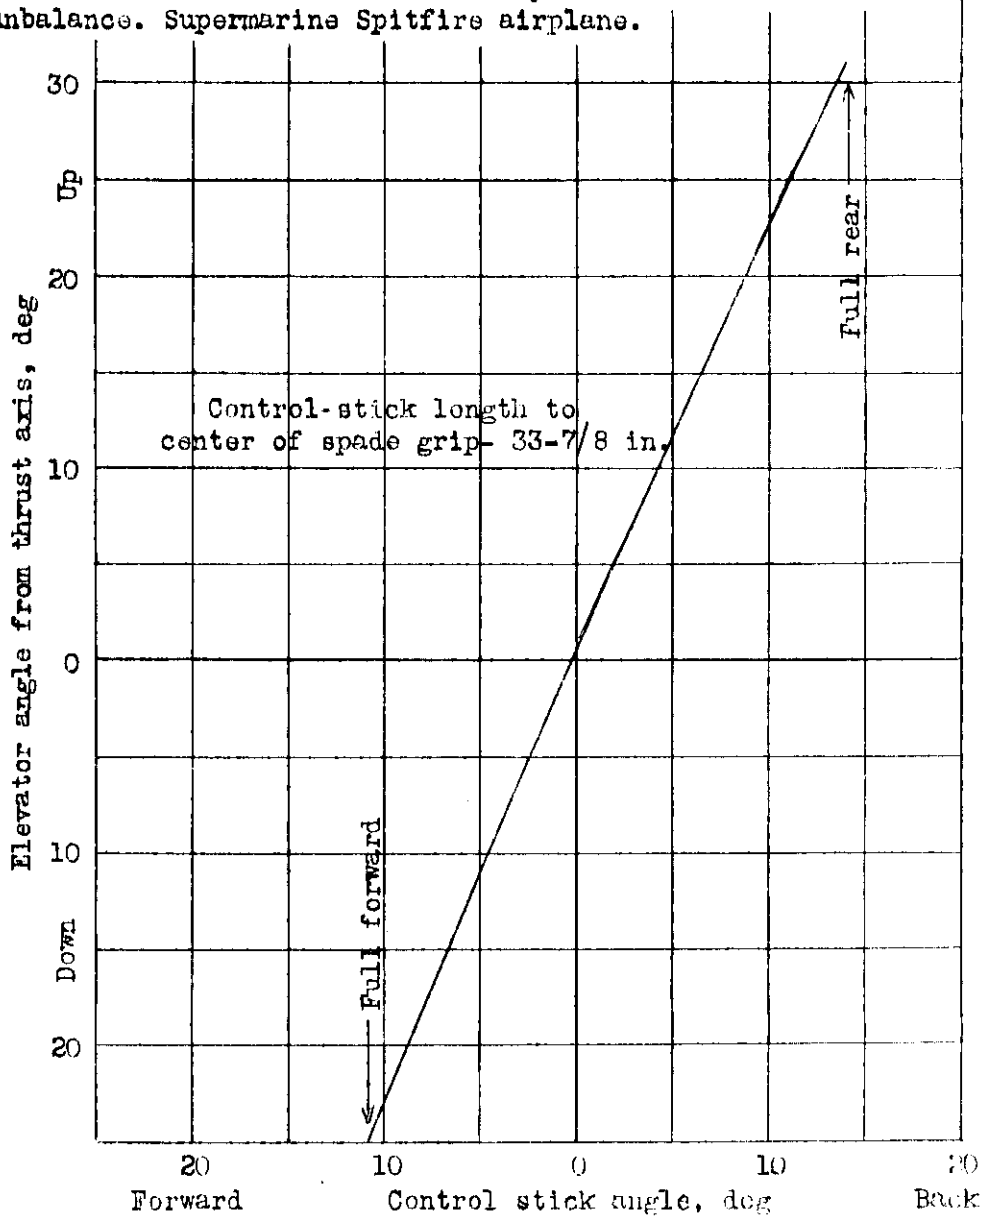
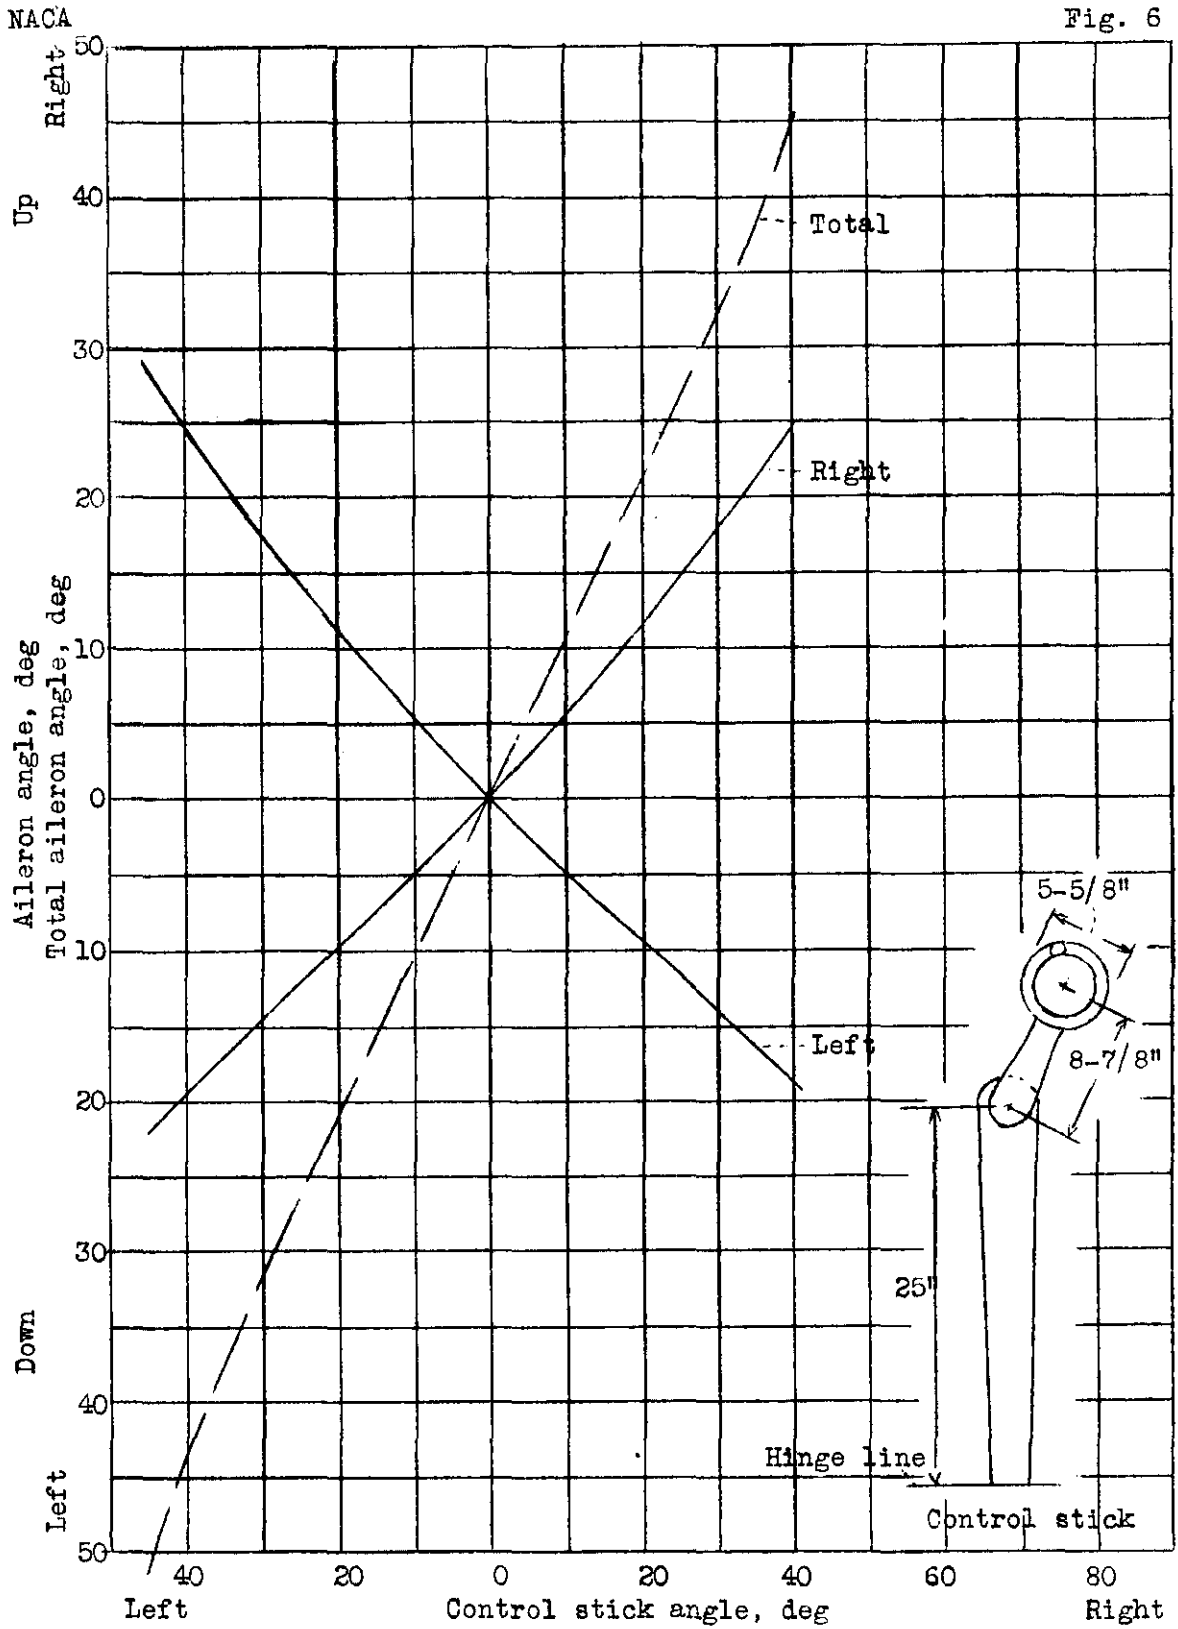
Figure 6.- Variation of left, right, and total-aileron angles with control stick angle. Supermarine Spitfire airplane.

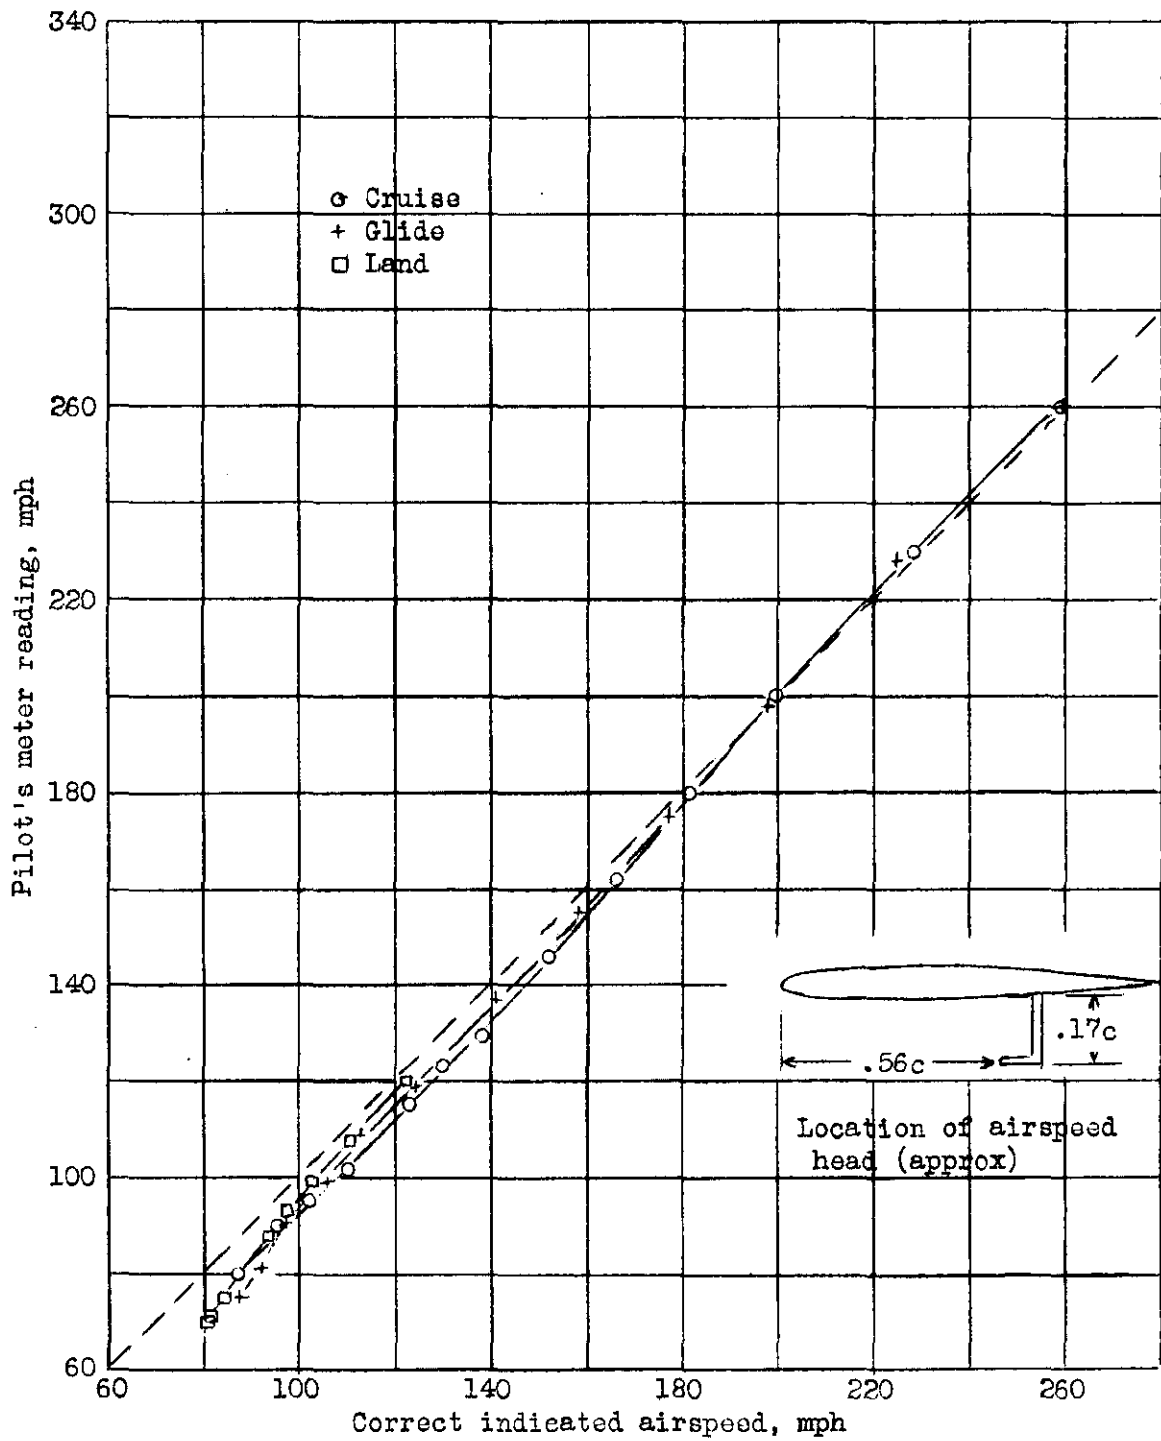
Figure 7.- Calibration of the pilot's airspeed indicator in the Supermarine Spitfire airplane.

The readings of the pilot's meter as compared to the correct indicated airspeed in the cruising, gliding, and landing conditions of flight are plotted on figure 7. The correct speed was determined by flying in formation with another airplane. The calibration of the airspeed recorder in the latter airplane was made by the use of a trailing airspeed head. The installation of the airspeed indicator in the Spitfire consisted of a pitot-static head

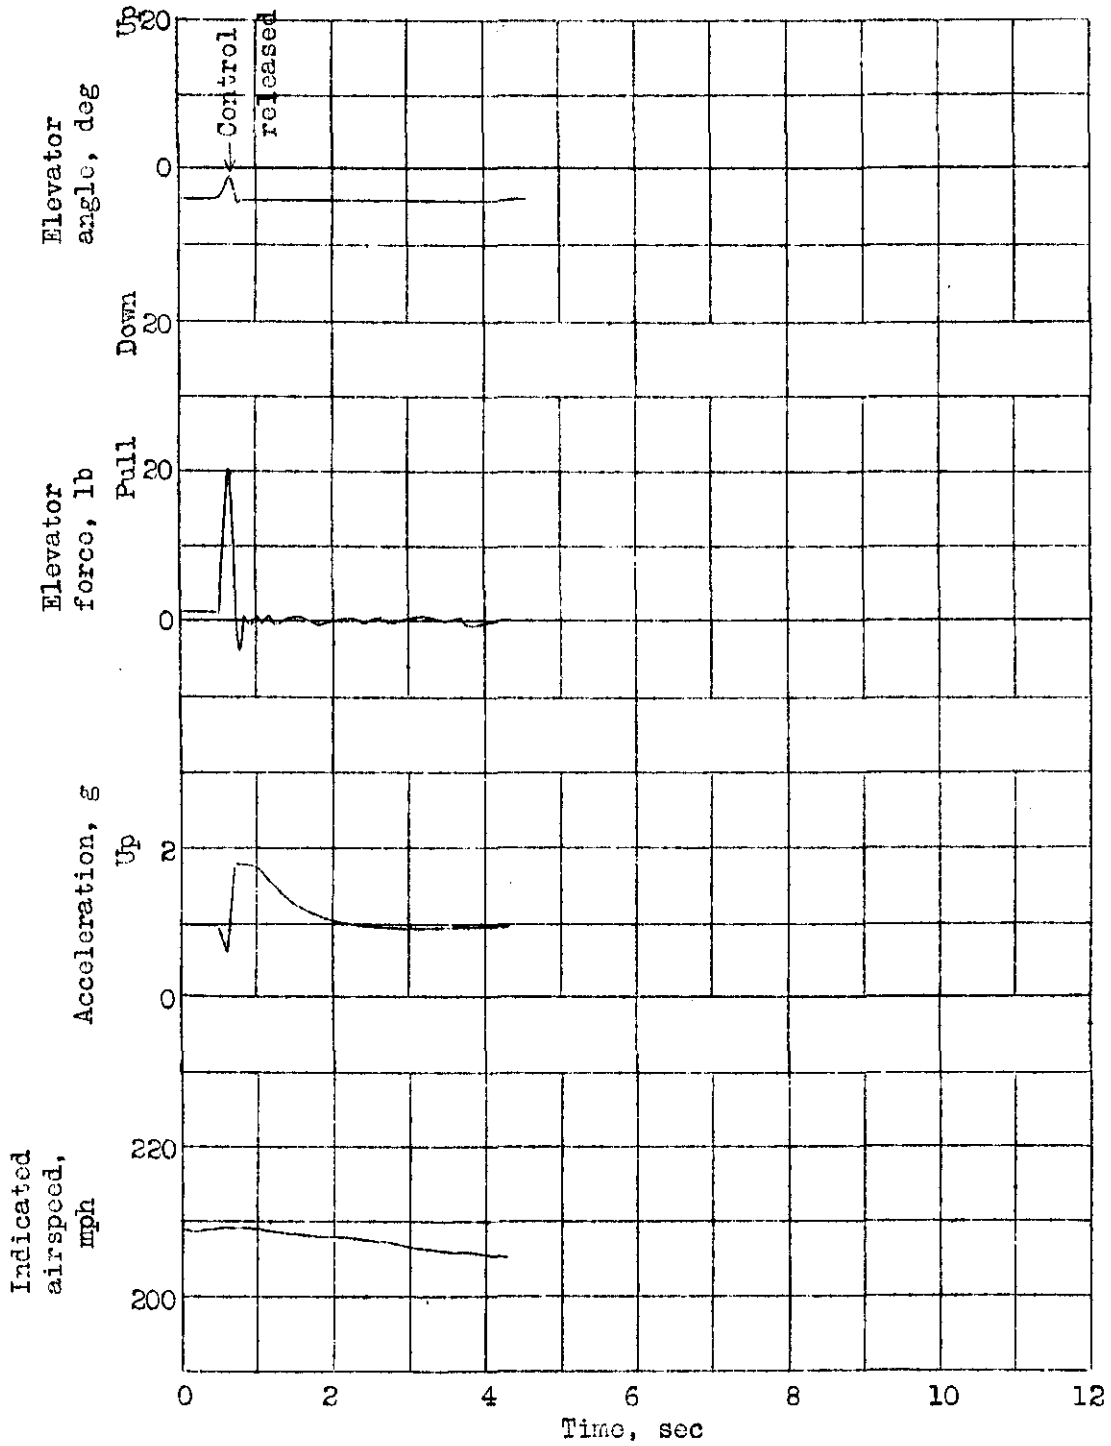
Figure 8.- Time history of a short-period oscillation started by suddenly pulling back the control stick and releasing it in level flight; flaps and gear up. Supermarine Spitfire airplane.

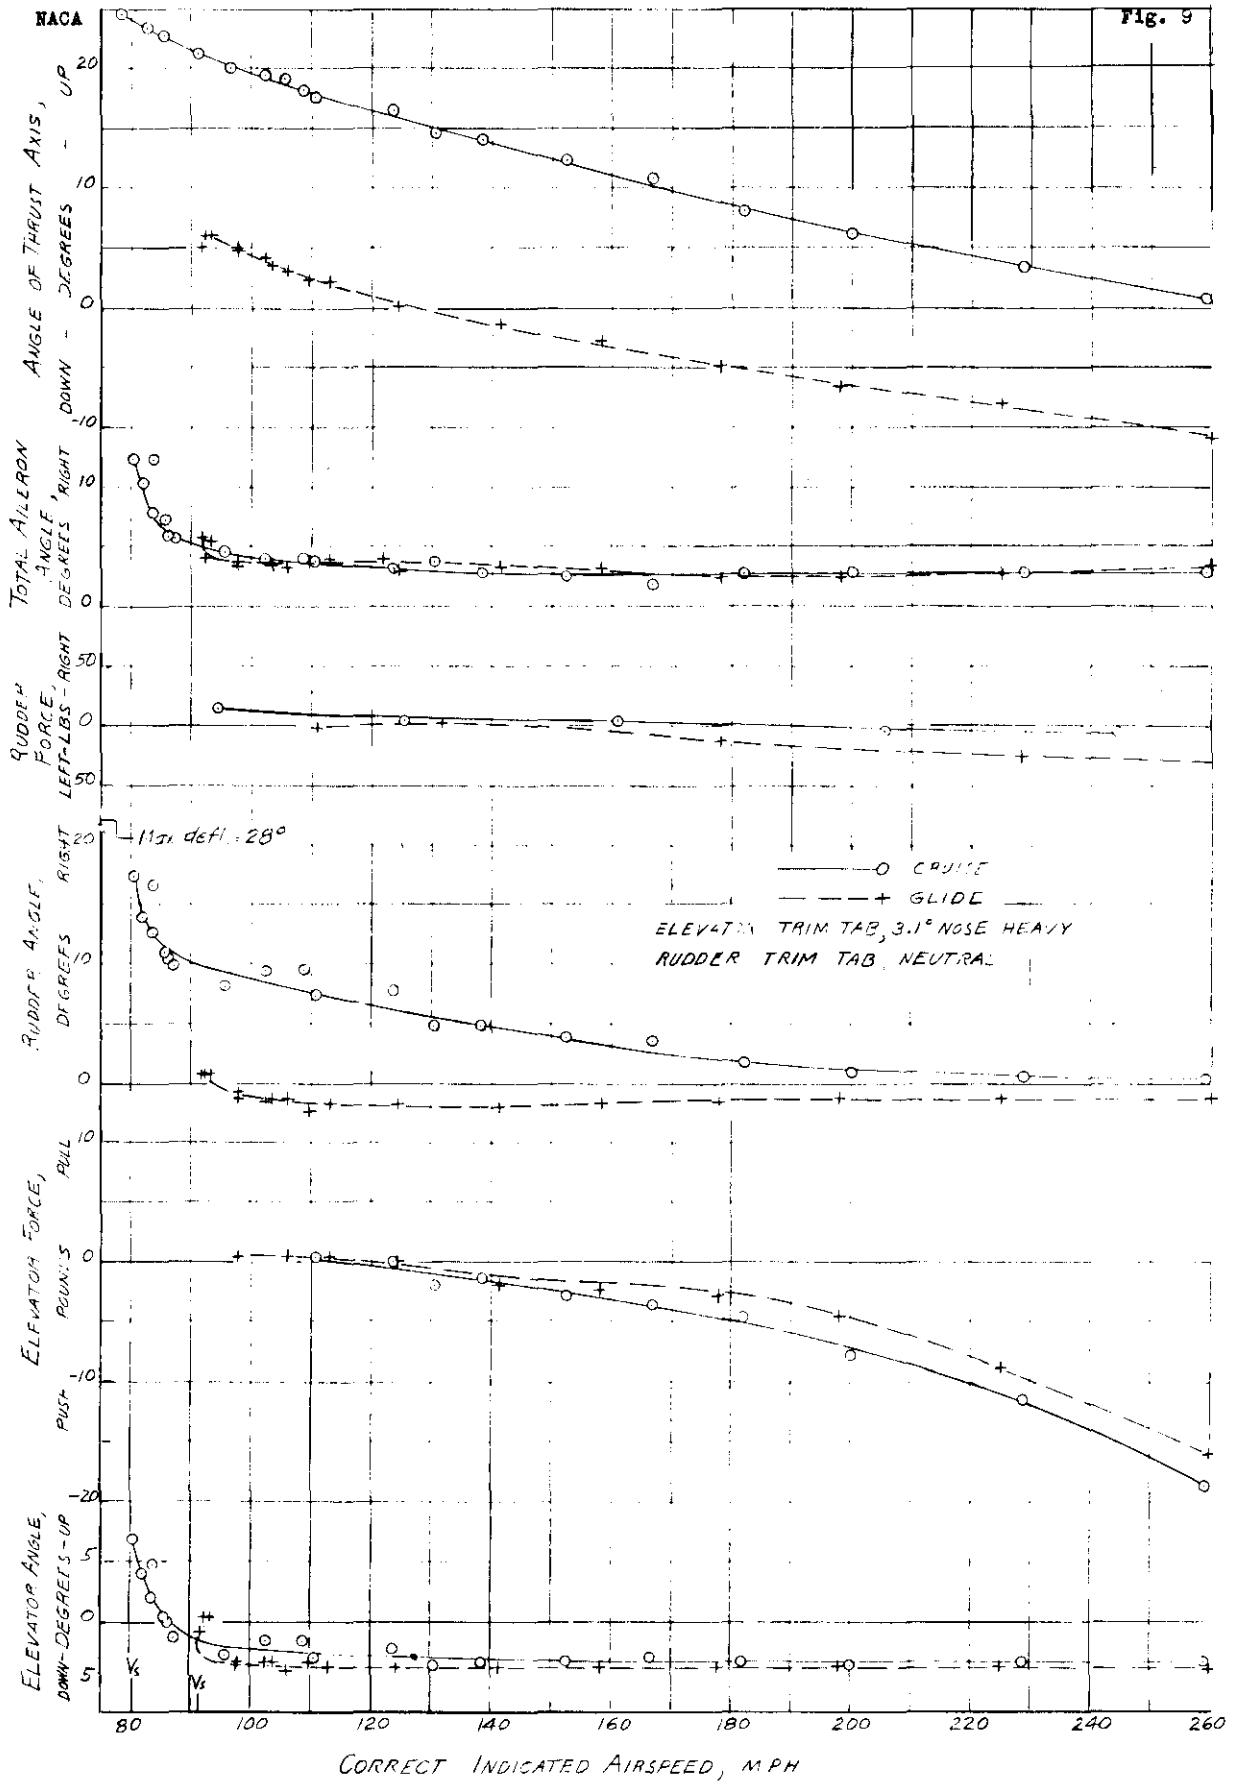
Figure 9. - Static longitudinal-stability characteristics of the Supermarine Spitfire airplane in the cruising and gliding conditions.

2. In spite of the neutral stick-fixed static stability with flaps up, the airplane had a slightly stable stick-force variation with airspeed throughout the speed range (fig. 9). This stable stick-force gradient is attributed to the unbalanced elevator. If a completely mass-balanced elevator had been employed, the stick-force variation would have been slightly unstable, a condition consistent with neutral stick-fixed stability. In the flap-down condition with power on, the stick-force variation for the trim-tab setting used was unstable and, with power off, the stick-free stability was neutral. If the airplane had been trimmed for zero stick force at low speed, the variation might have been slightly stable with

4. The limits of elevator motion were not reached in steady flight from the minimum speed to the highest speeds tested. Figures 9, 10, and 11 show that in all conditions only a few degrees of elevator motion were required to trim throughout the speed range.

Characteristics of longitudinal trimming device.- Because the trim changes required for the different flight conditions were so small, the elevator trim tabs had ample power to trim the airplane at any speed in any flight condition for the center-of-gravity location used in these tests. In order to determine the power of the elevator trim tabs, measurements of the elevator forces required for trim with different trim-tab settings were made at various speeds. The change in stick force per degree trim-tab change is plotted as a function of speed for three flight conditions in figure 24. The variation of stick force with speed for any trim-tab setting may be obtained by adding to the forces plotted on figures 9, 10, and 11 the force caused by the change in trim-tab angle.

Considerable deflection of the rudder to the right was required in the power-on conditions in steady flight near minimum speed as shown on figures 9, 10, and 11. The limits of rudder travel were never exceeded, however. The rudder deflection is needed partly to offset the yawing moment caused by angularity of the flow due to the slipstream, and partly to balance the left yawing moment of the propeller itself that results from the high angle of attack of the propeller axis. The side force on the rudder necessary to maintain equilibrium of yawing moments

The rudder forces required for trim throughout the speed range with the rudder trim tab neutral are plotted for the gliding and cruising conditions on figure 9. These rudder forces were unusually light.

Power of rudder and aileron trimming devices.- The trim tab provided on the rudder was sufficiently powerful to reduce the rudder force to zero in any flight condition. The rudder forces required for trim with the trim tab neutral are plotted on figure 9. No trim tab was provided on the ailerons, but the aileron forces for trim were light. The aileron angles required for trim throughout the speed range in the various flight conditions are plotted in figures 9, 10, and 11.

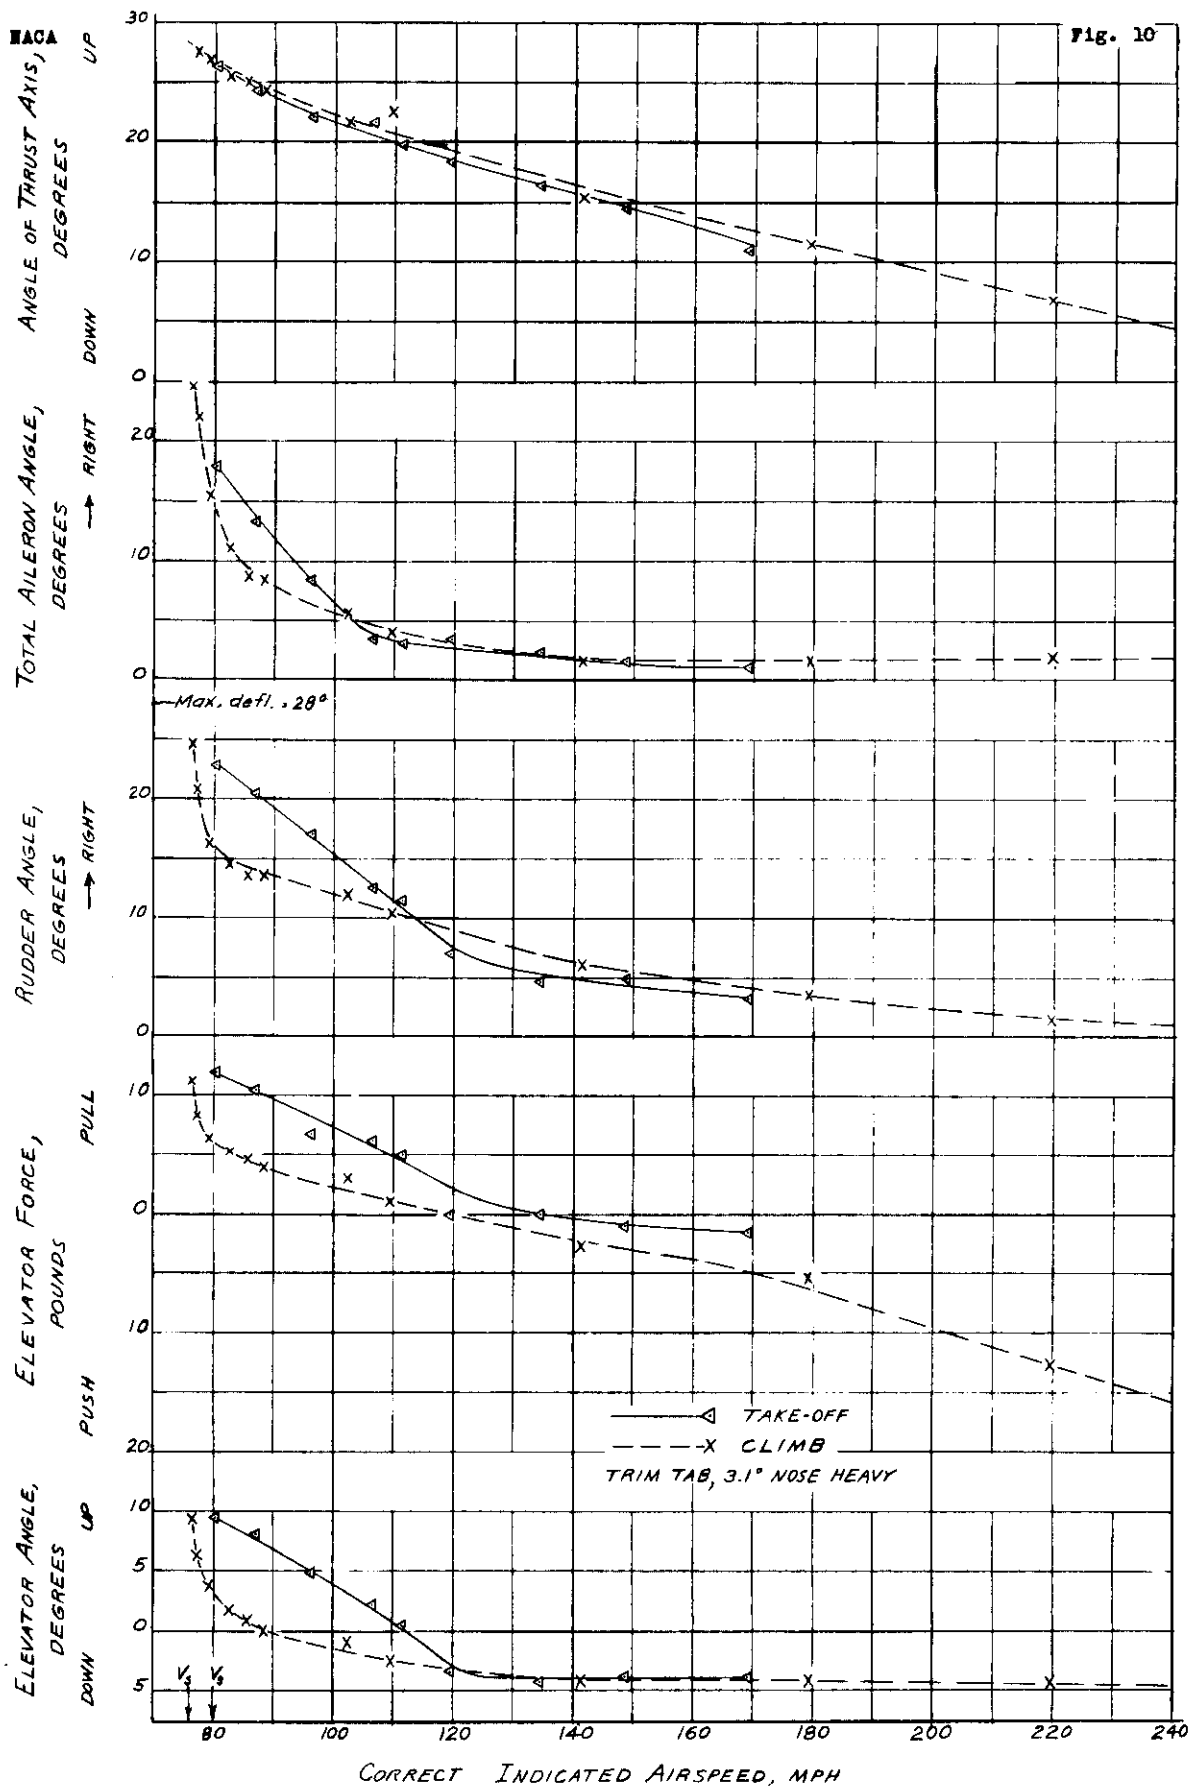
Figure 10. - Static longitudinal-stability characteristics of the Supermarine Spitfire airplaneTM in the climbing and take-off conditions.

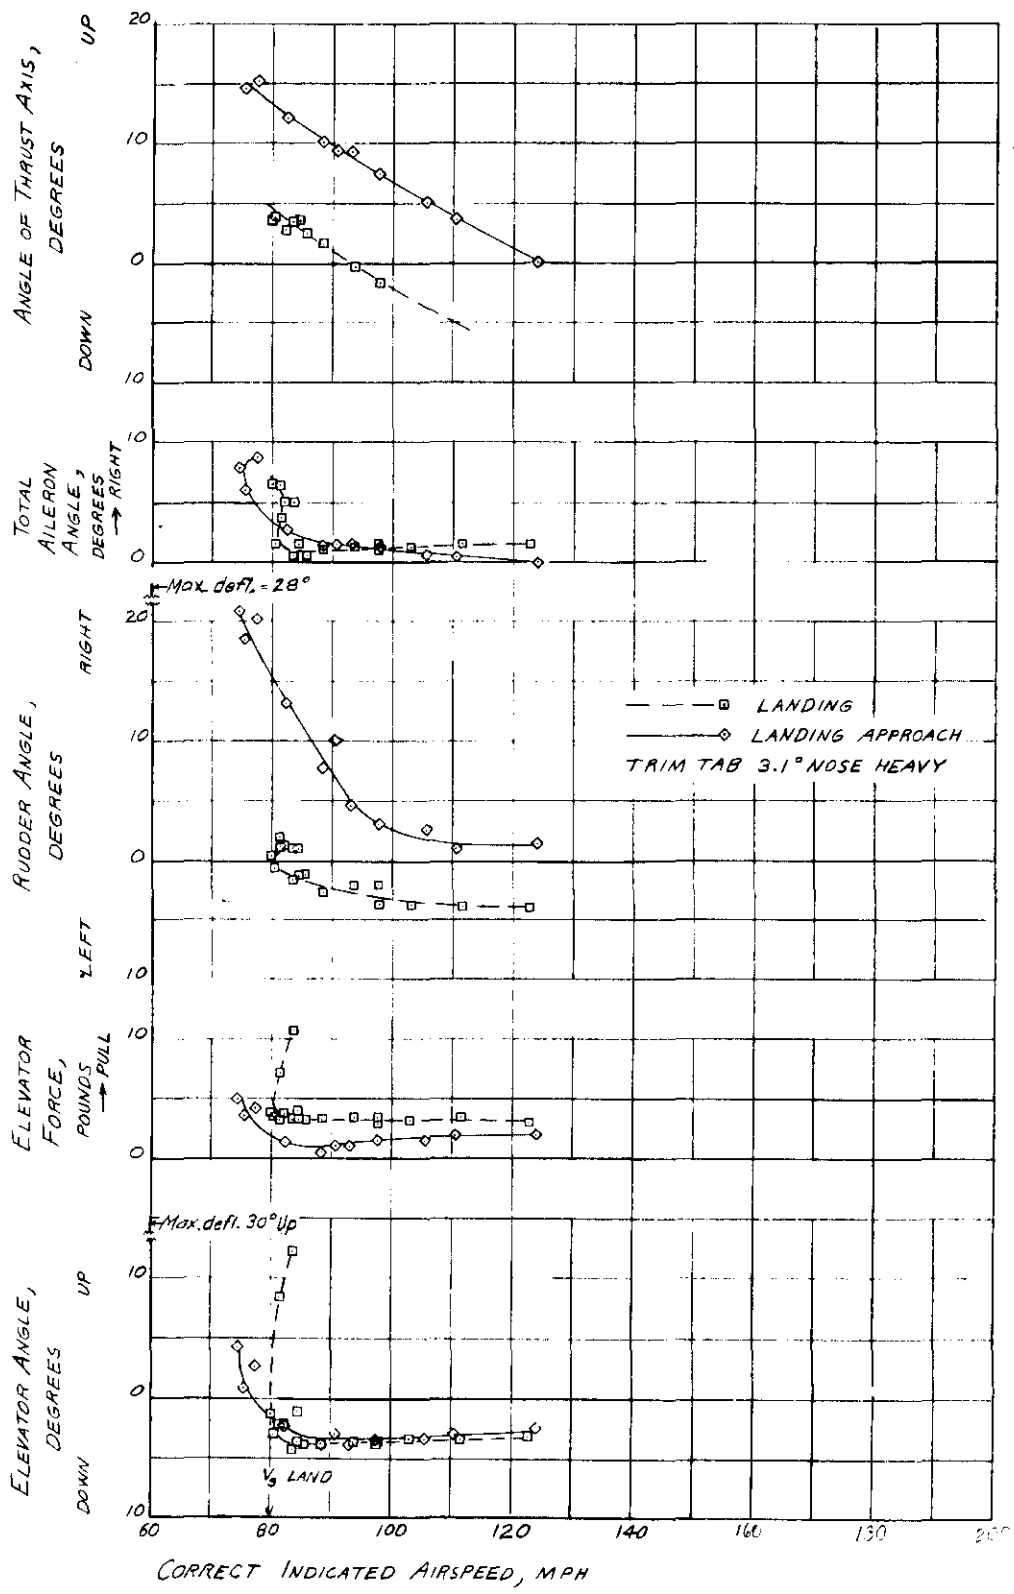
Figure 11. - Static longitudinal-stability characteristics of the Supermarine Spitfire airplane in the landing and landing-approach conditions.

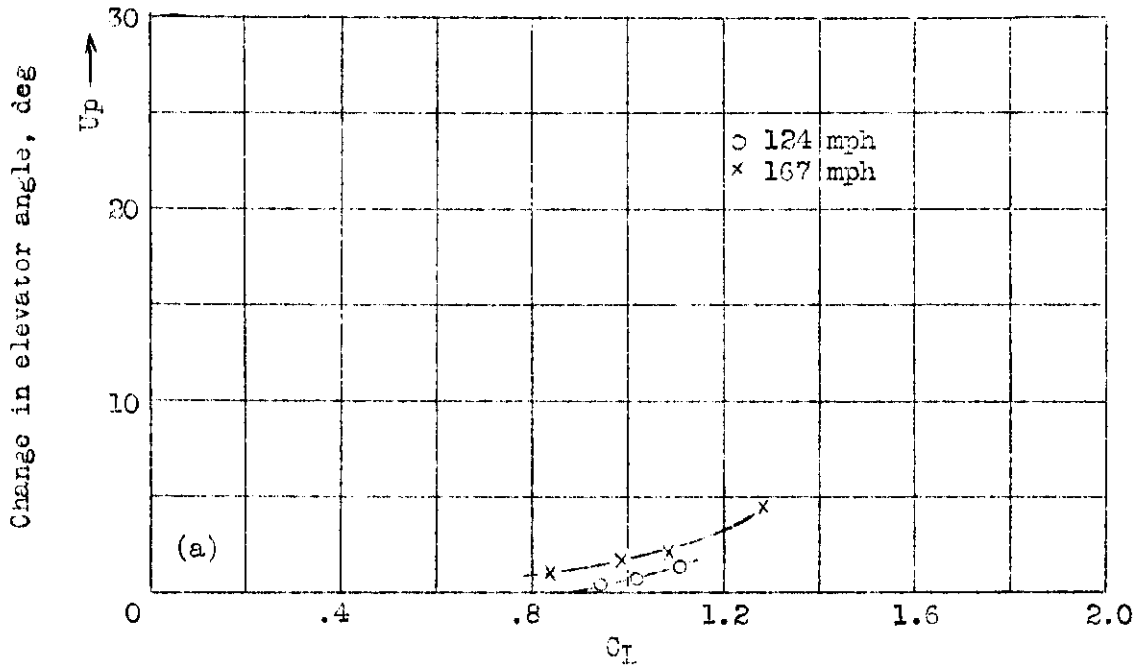
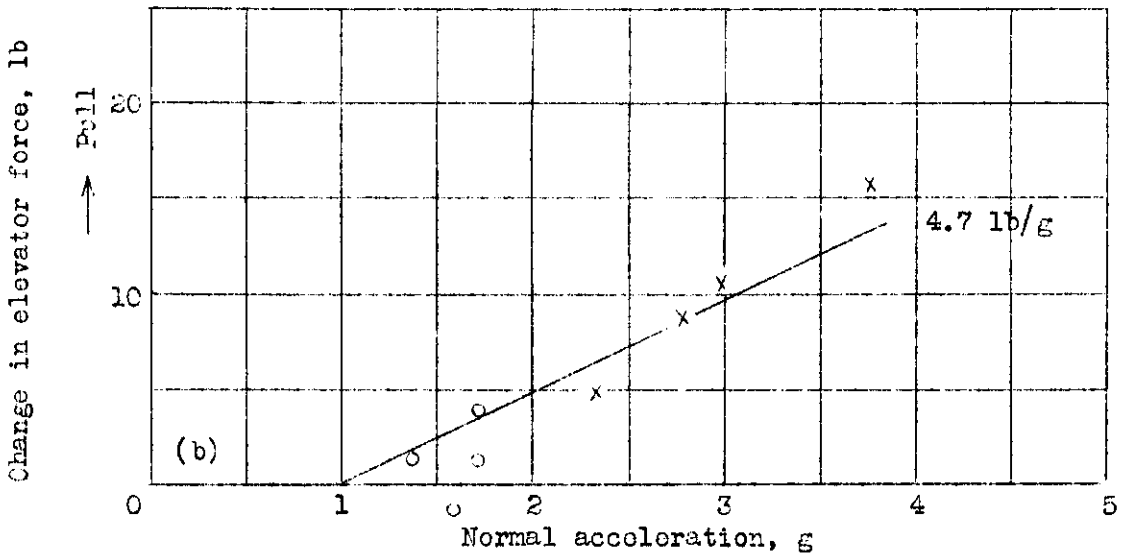
(a) Variation of change in elevator angle with lift coefficient in pull-ups.

(b) Variation of elevator force with normal acceleration in pull-ups.

Figure 12.- Elevator characteristics in pull-ups. Supermarine Spitfire airplane.

The elevator control was found to be powerful enough to develop either the maximum lift coefficient or the allowable load factor at any speed. As shown in figure 12(a), less than 5° movement of the elevator was used in reaching maximum lift coefficient in pull-ups from level flight. In these maneuvers, the elevator was abruptly deflected a small amount and then held fixed with the aid of a graduated tape in the cockpit. In pull-ups made at high speed, the elevator was always eased forward before maximum acceleration had been developed, in order to avoid overloading the structure.

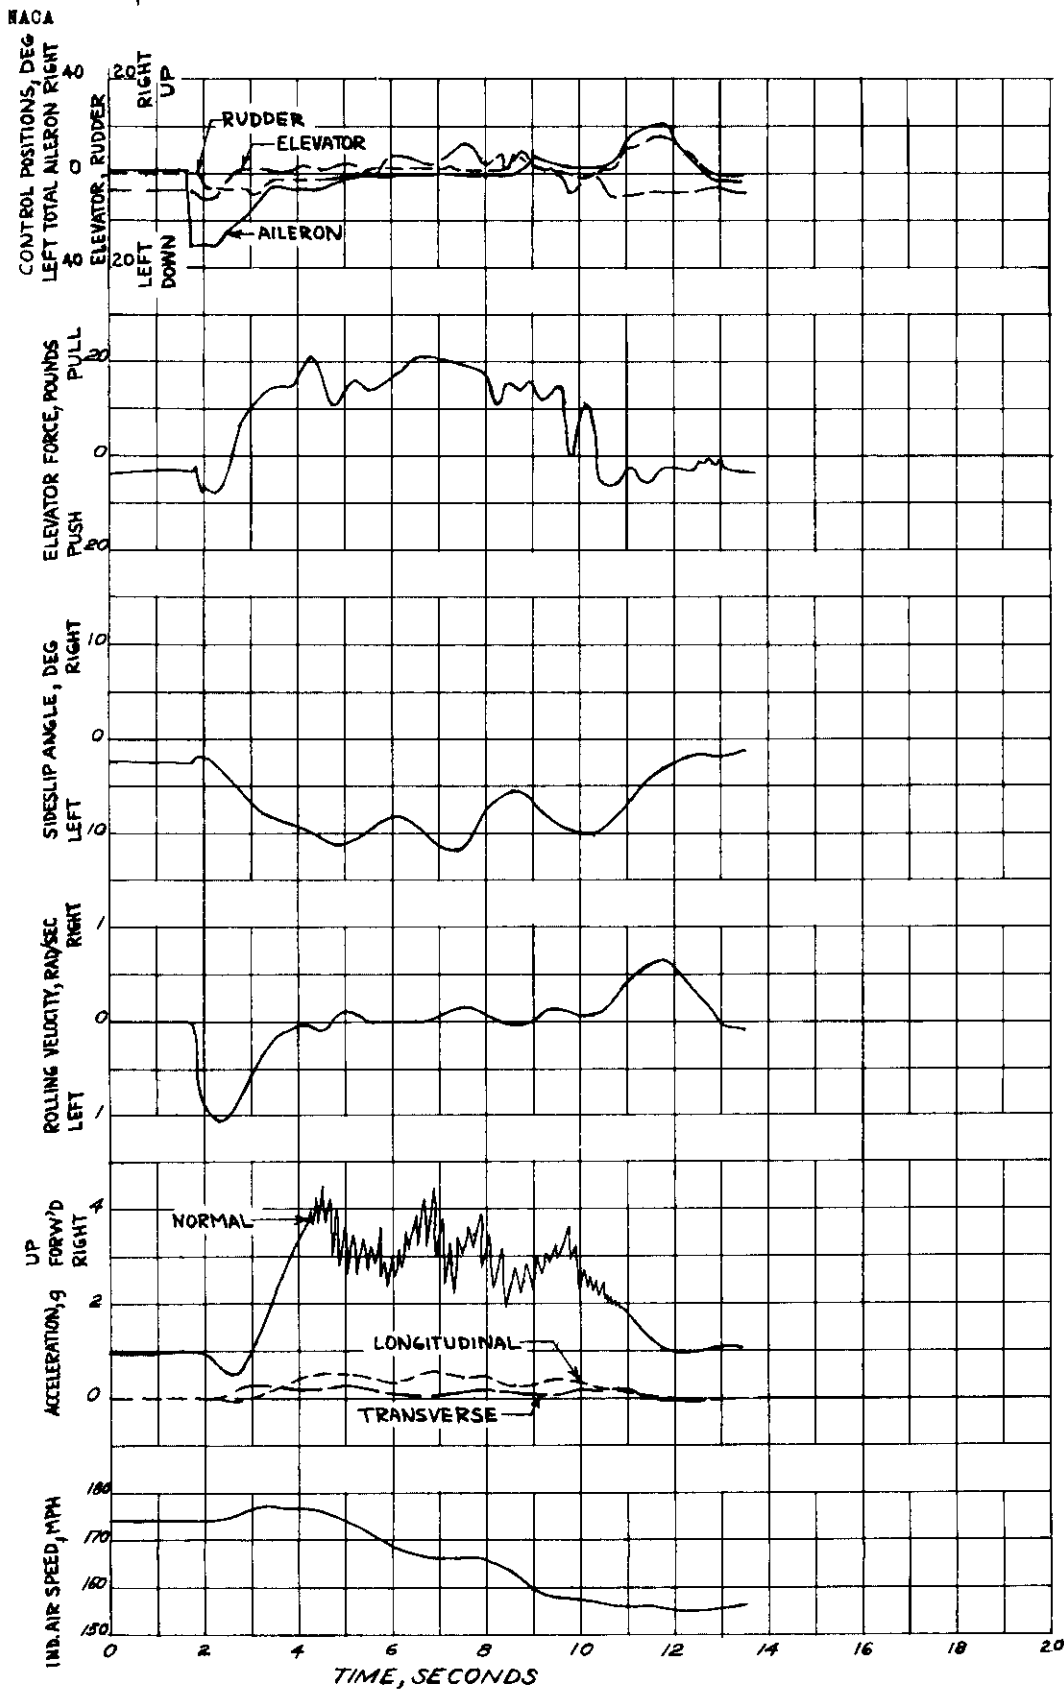
Figure 13. - Time history of a rapid 180° turn to the left started at 174 miles per hour, in which the stall was reached. Supermarine Spitfire airplane; gun parts covered.

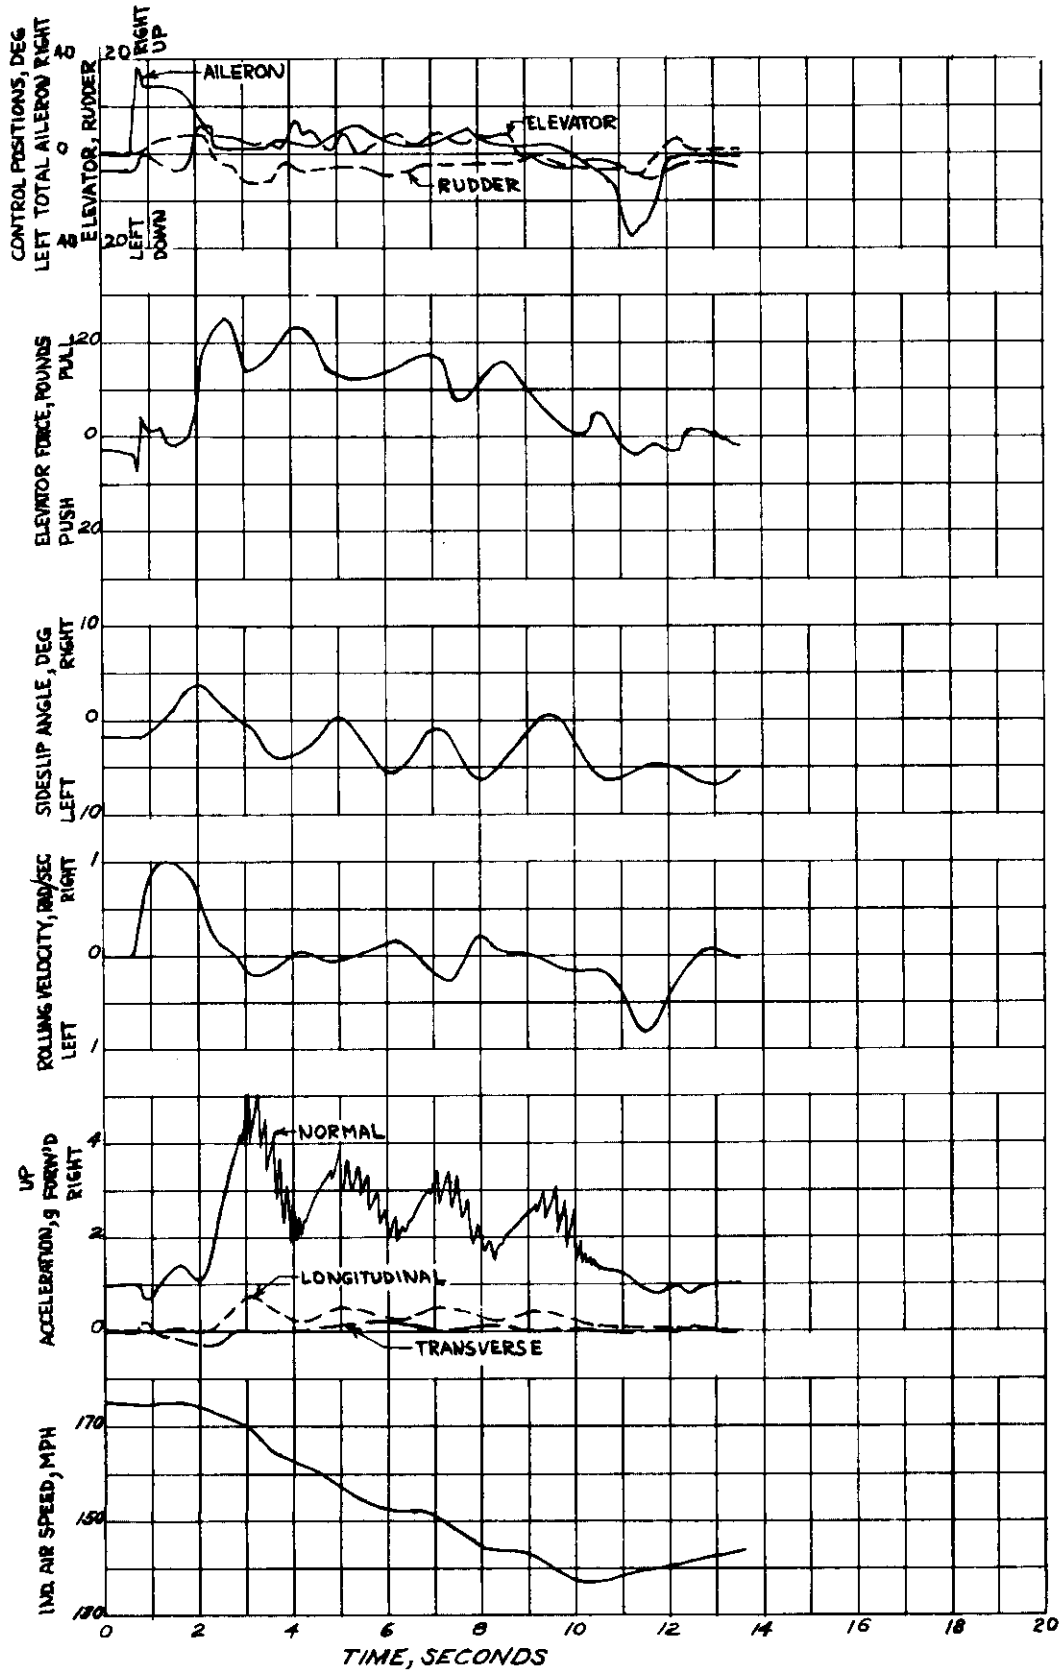
Figure 14. - Time history of a rapid 180° turn to the right started at 175 miles per hour, in which four stalls occurred. Supermarine Spitfire airplane with gun parts covered.
