NATIONAL ADVISORY COMMITTEE FOR AERONAUTICS

ADVANCE CONFIDENTIAL REPORT

MEASUREMENTS OF THE FLYING QUALITIES OF A
SUPERMARINE SPITFIRE VA AIRPLANE

By William H. Phillips and Joseph R. Vensel

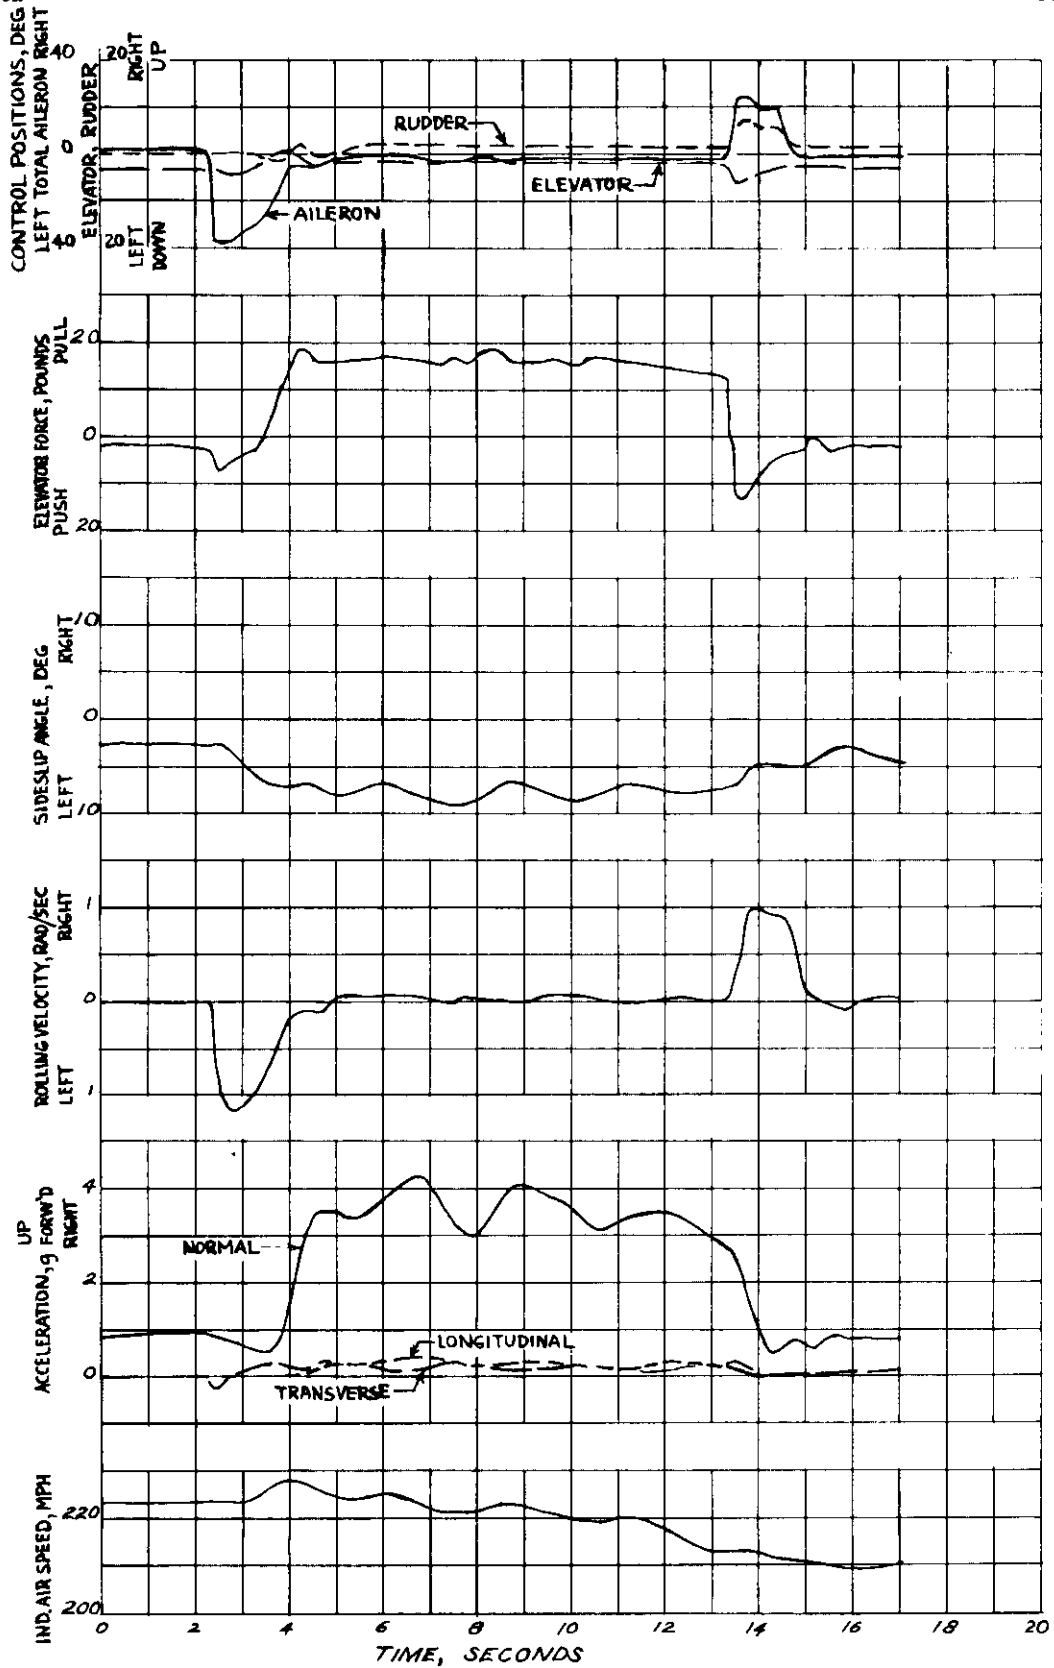
Fig. 15

Figure 15. - Time history of a rapid 180° turn to the left started at 223 miles per hour. Supermarine Spitfire airplane with gun ports covered.

the static stability of an airplane is sufficiently large. By careful flying, the pilot was able to make smooth turns at high speed, as shown by figures 17 and 18. Ordinarily, however, small movements of the stick caused appreciable variations in the normal acceleration, as shown in figures 15 and 20.

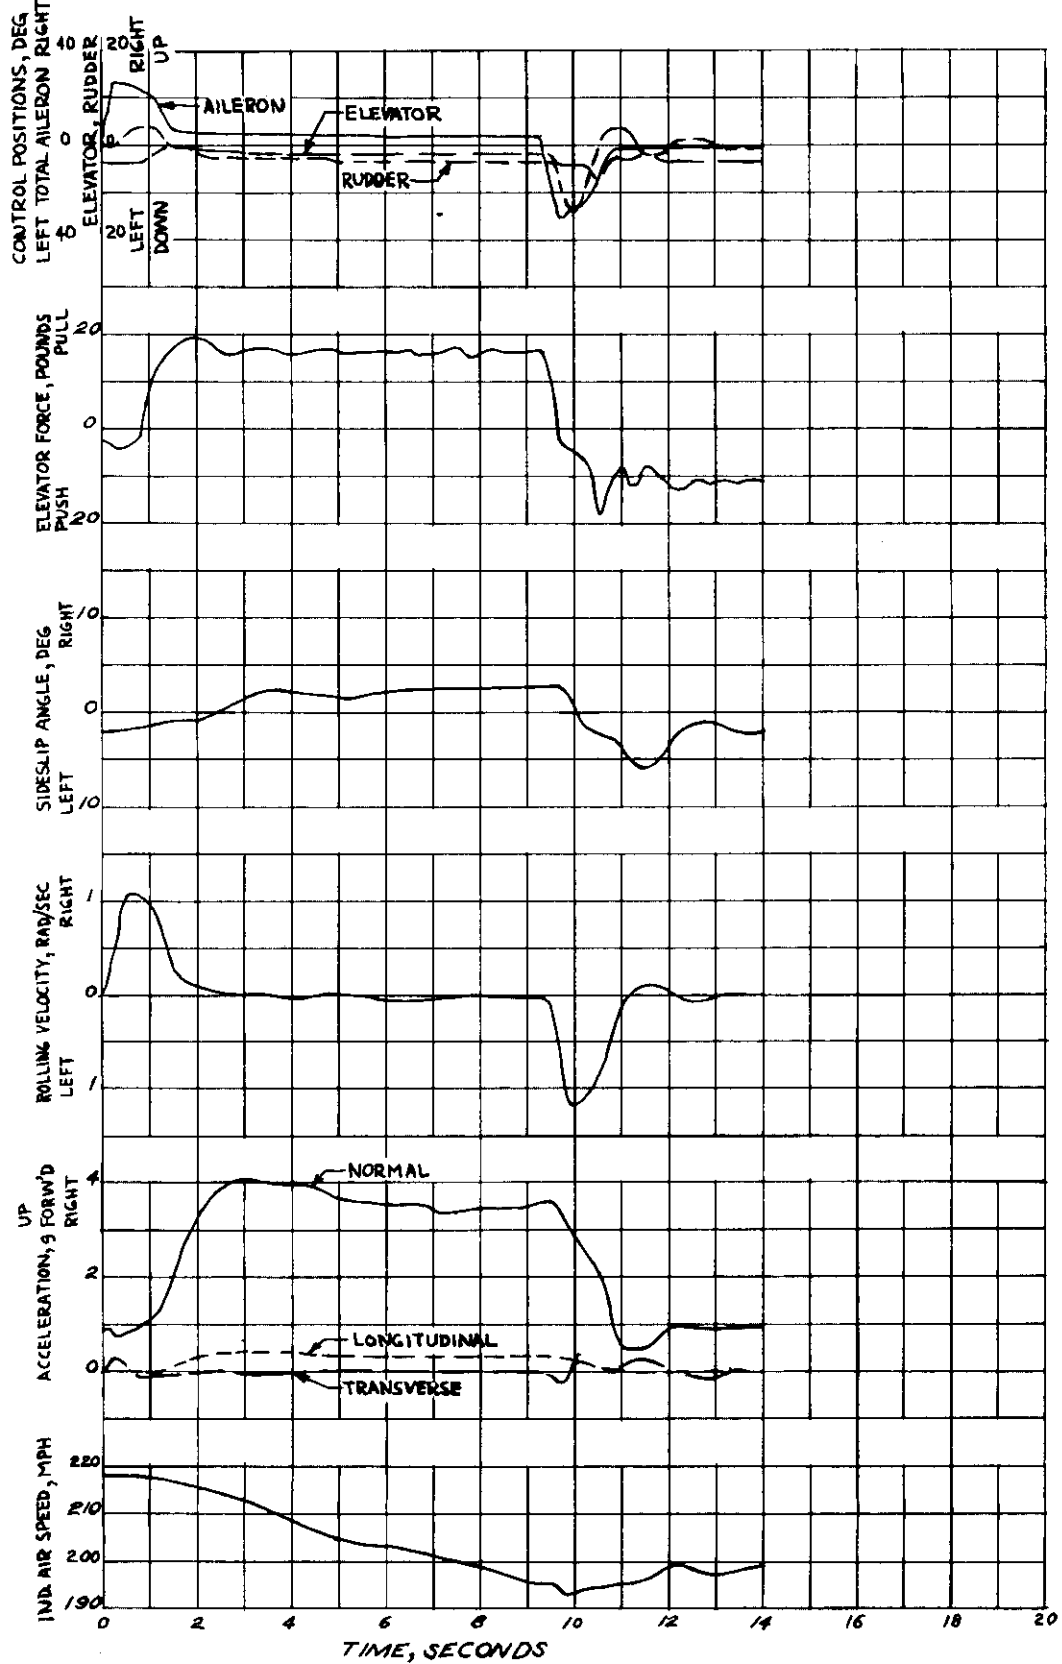
Figure 16. - Time history of a rapid 180° turn to the right started at 218 miles per hour. Supermarine Spitfire airplane with gun ports covered.

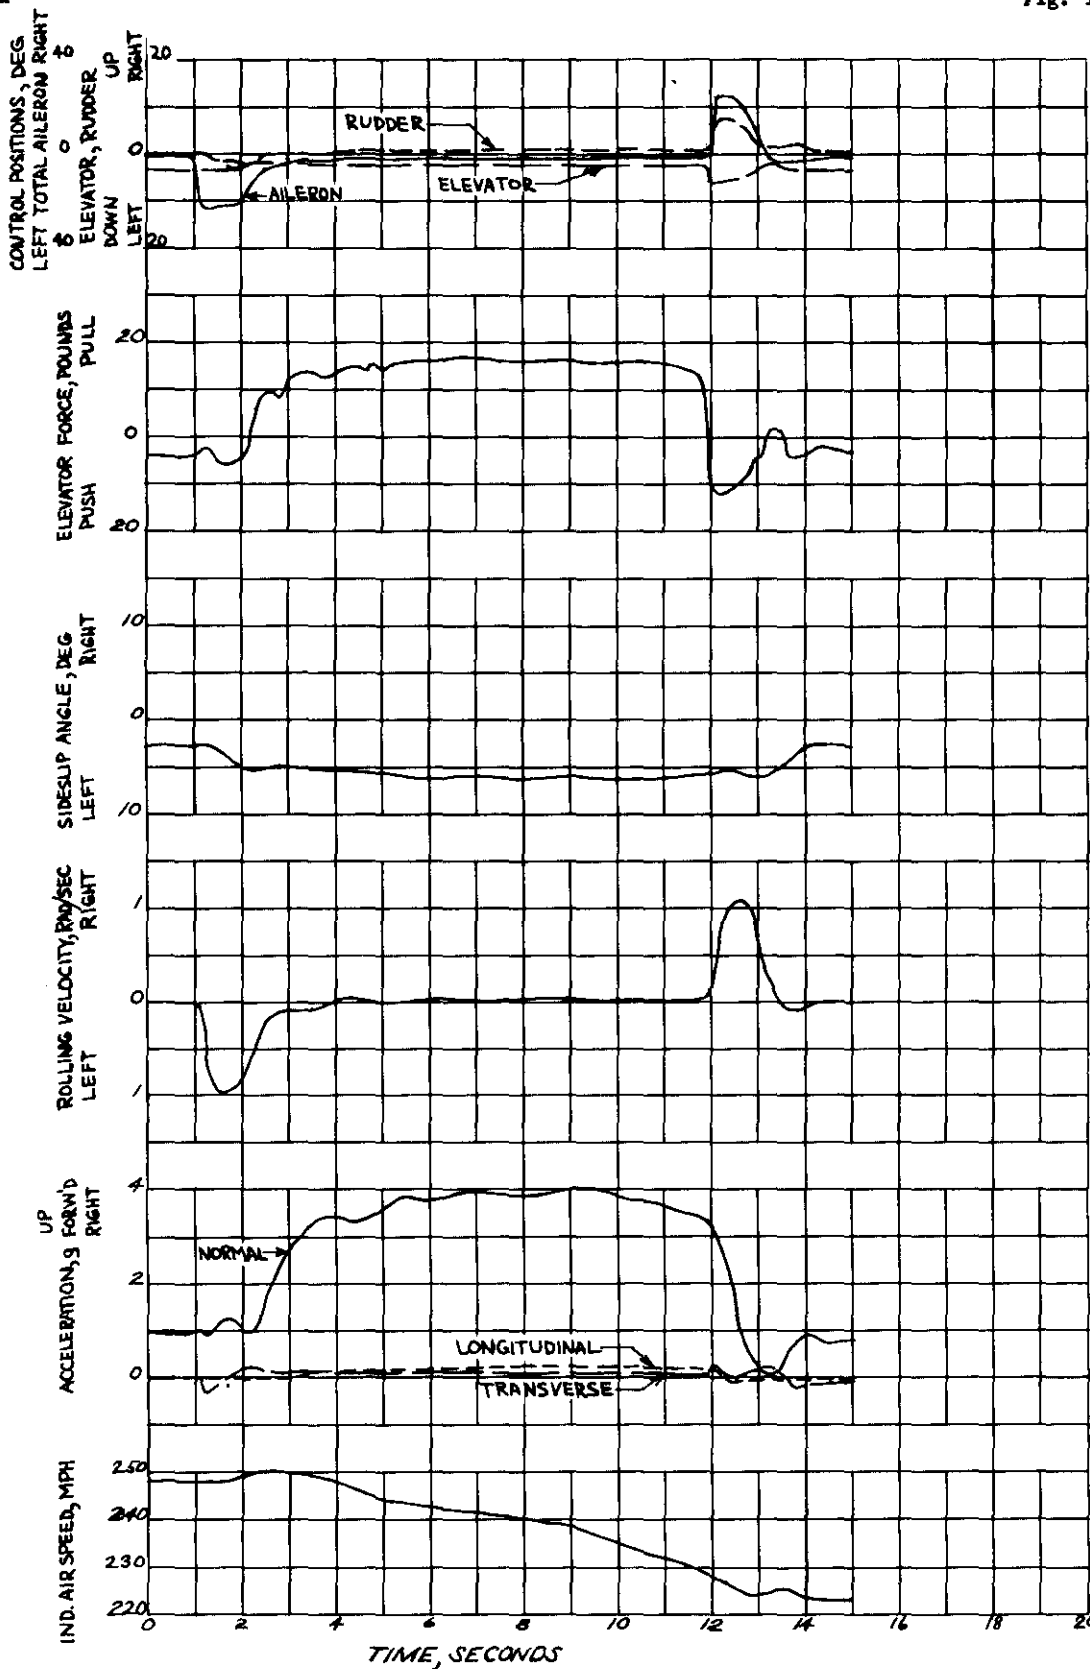
Figure 17. - Time history of a rapid 180° turn to the left started at 248 miles per hour. Supermarine Spitfire airplane with gun ports covered.

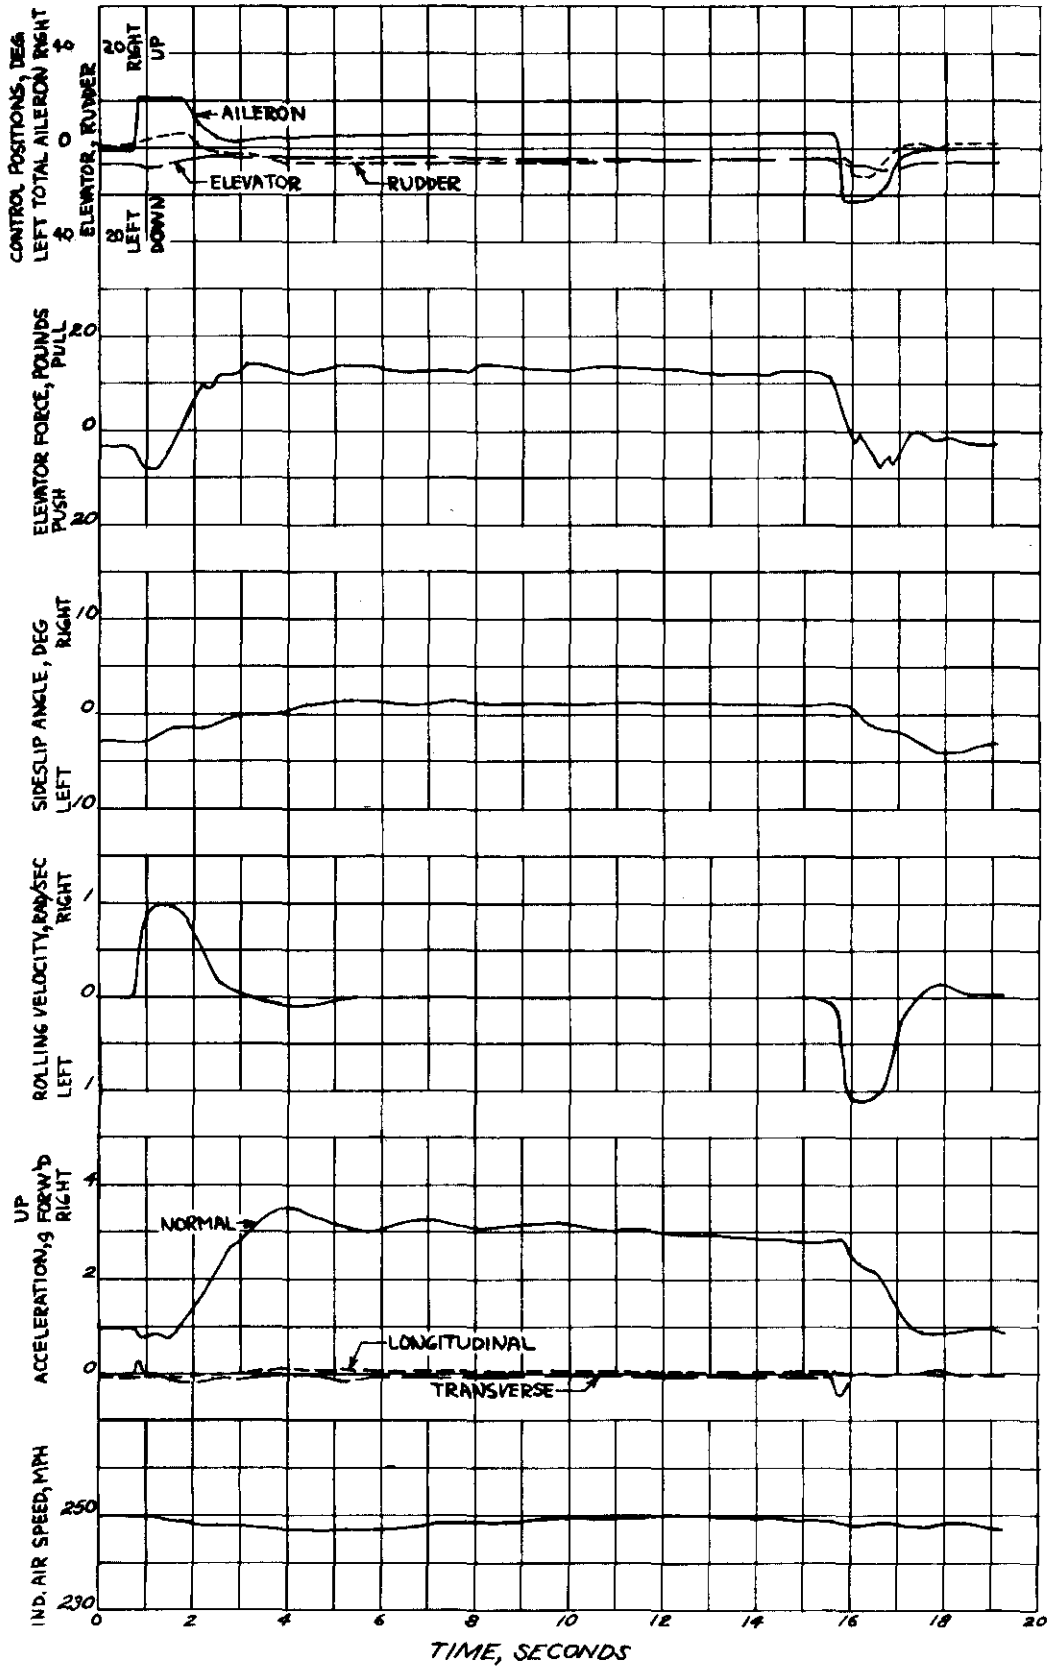
Figure 18. - Time history of a rapid 180° turn to the right started at 250 miles per hour. Supermarine Spitfire airplane with gun parts covered.

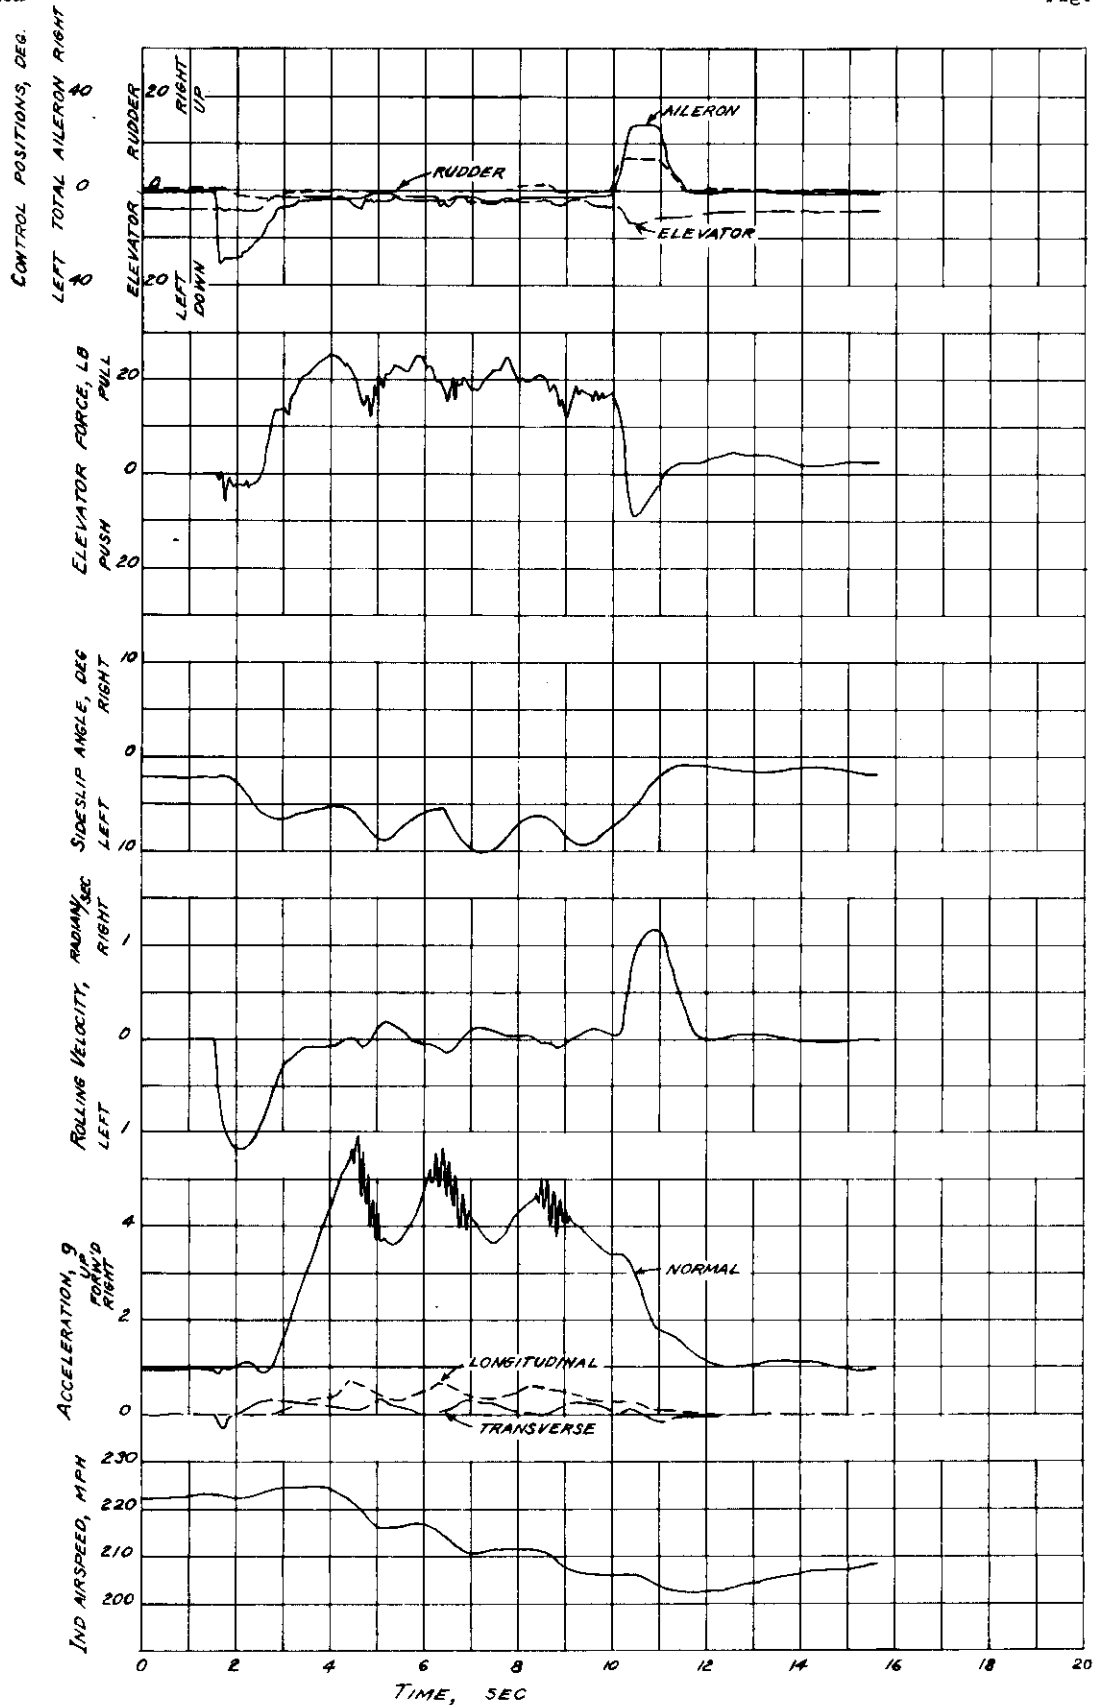
Figure 19. - Time history of a highly accelerated left turn in which the stall was reached three times. Supermarine Spitfire airplane with gun ports covered.

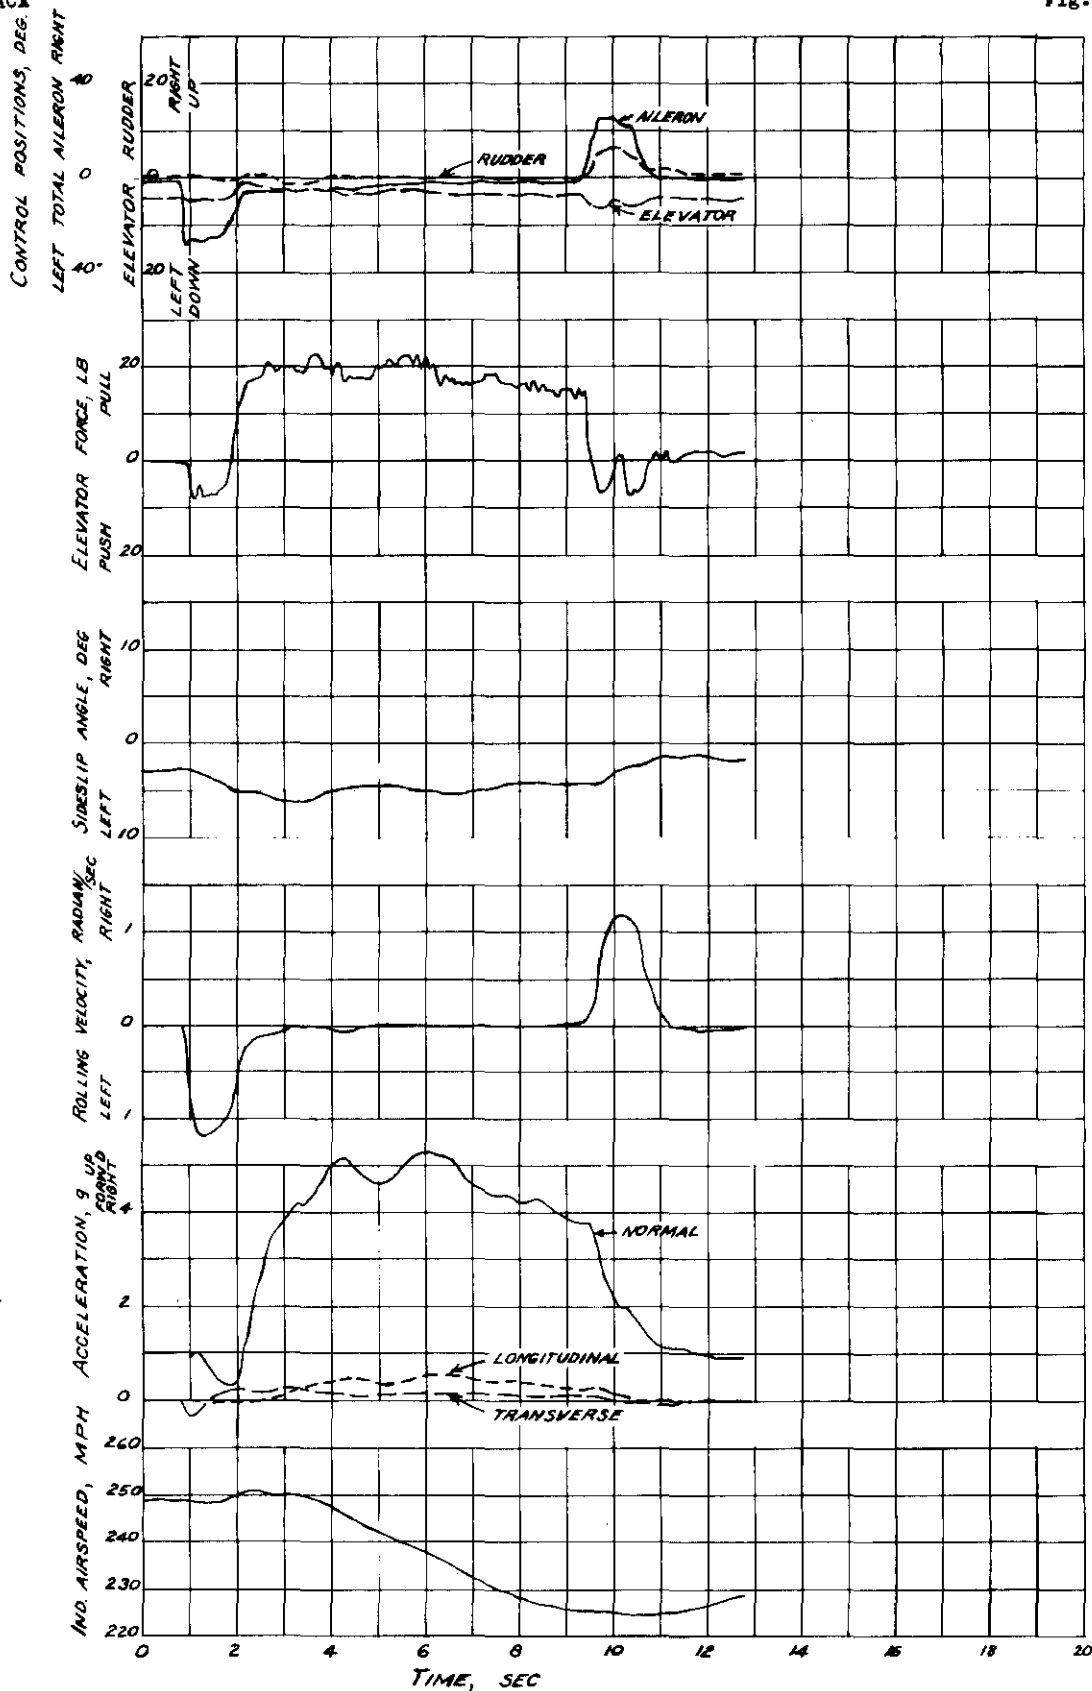
Figure 20. - Time history of a highly accelerated left turn started at 249 miles per hour. Supermarine Spitfire airplane with gun ports covered.

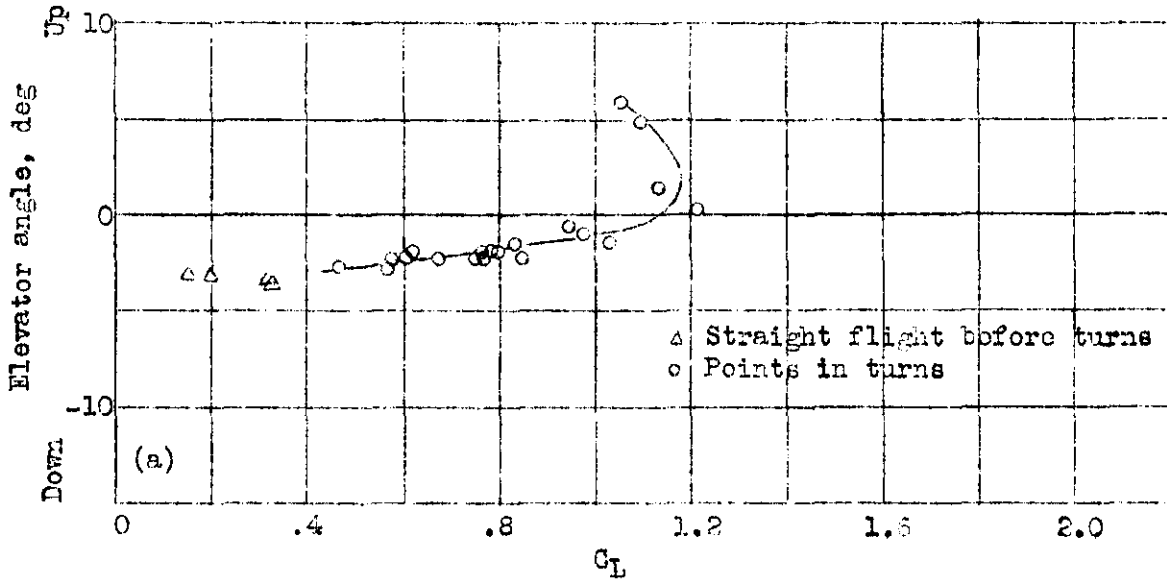
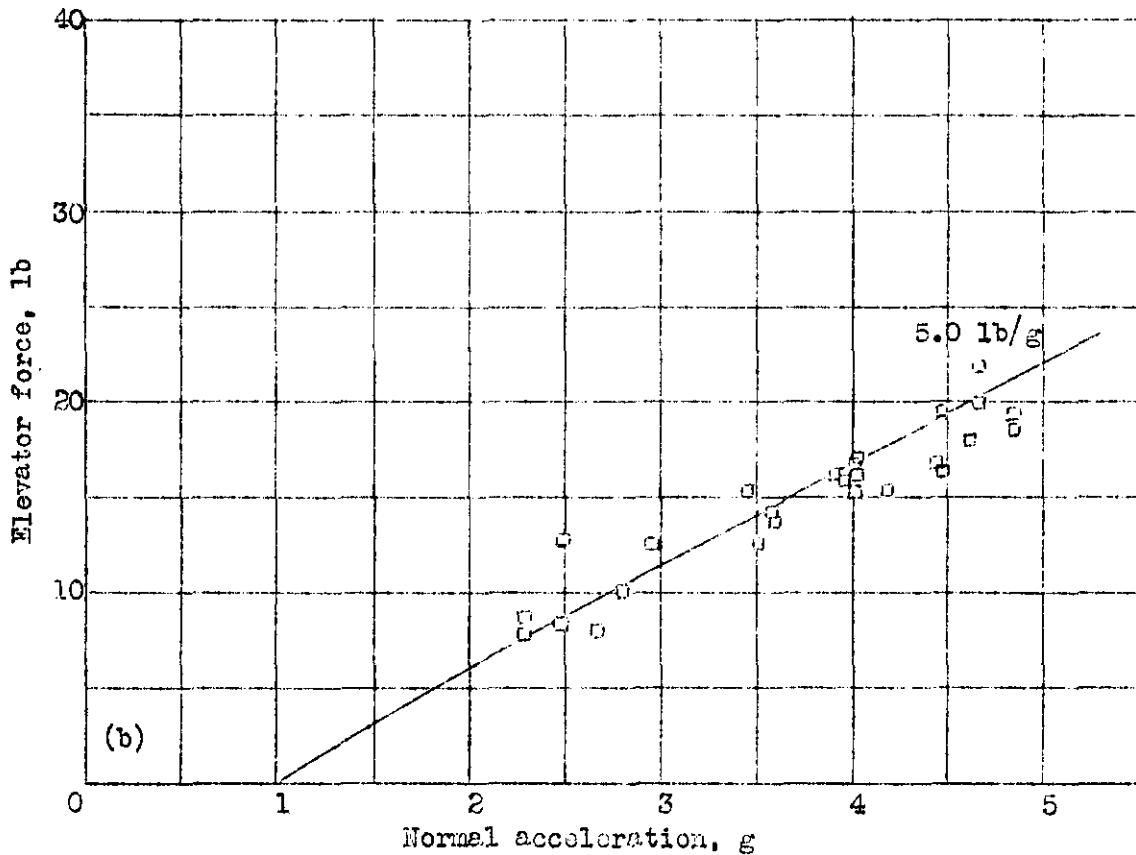
(a) Variation of elevator angle with lift coefficient in turns

(b) Variation of stick force with normal acceleration in turns.

Figure 21.- Elevator characteristics in turns. Supermarine Spitfire airplane.

The variation of stick force with normal acceleration in turns is plotted in figure 21(b). The stick-force gradient of 5.0 pounds per g was considered a little too light by most of the pilots. It is lower than the value of 6 pounds per g recommended as an upper limit in reference 1. Inasmuch as the elevator mass unbalance under static conditions gave a force of 4.0 pounds on the stick, it is apparent that the stick force required in accelerated flight came almost entirely from the statically unbalanced elevator. Practically no stick force would be required in turns if the elevator were mass balanced. This suggests that the airplane would appear definitely unstable in turns if the elevator were mass balanced, as is required for flutter prevention on American pursuit airplanes.

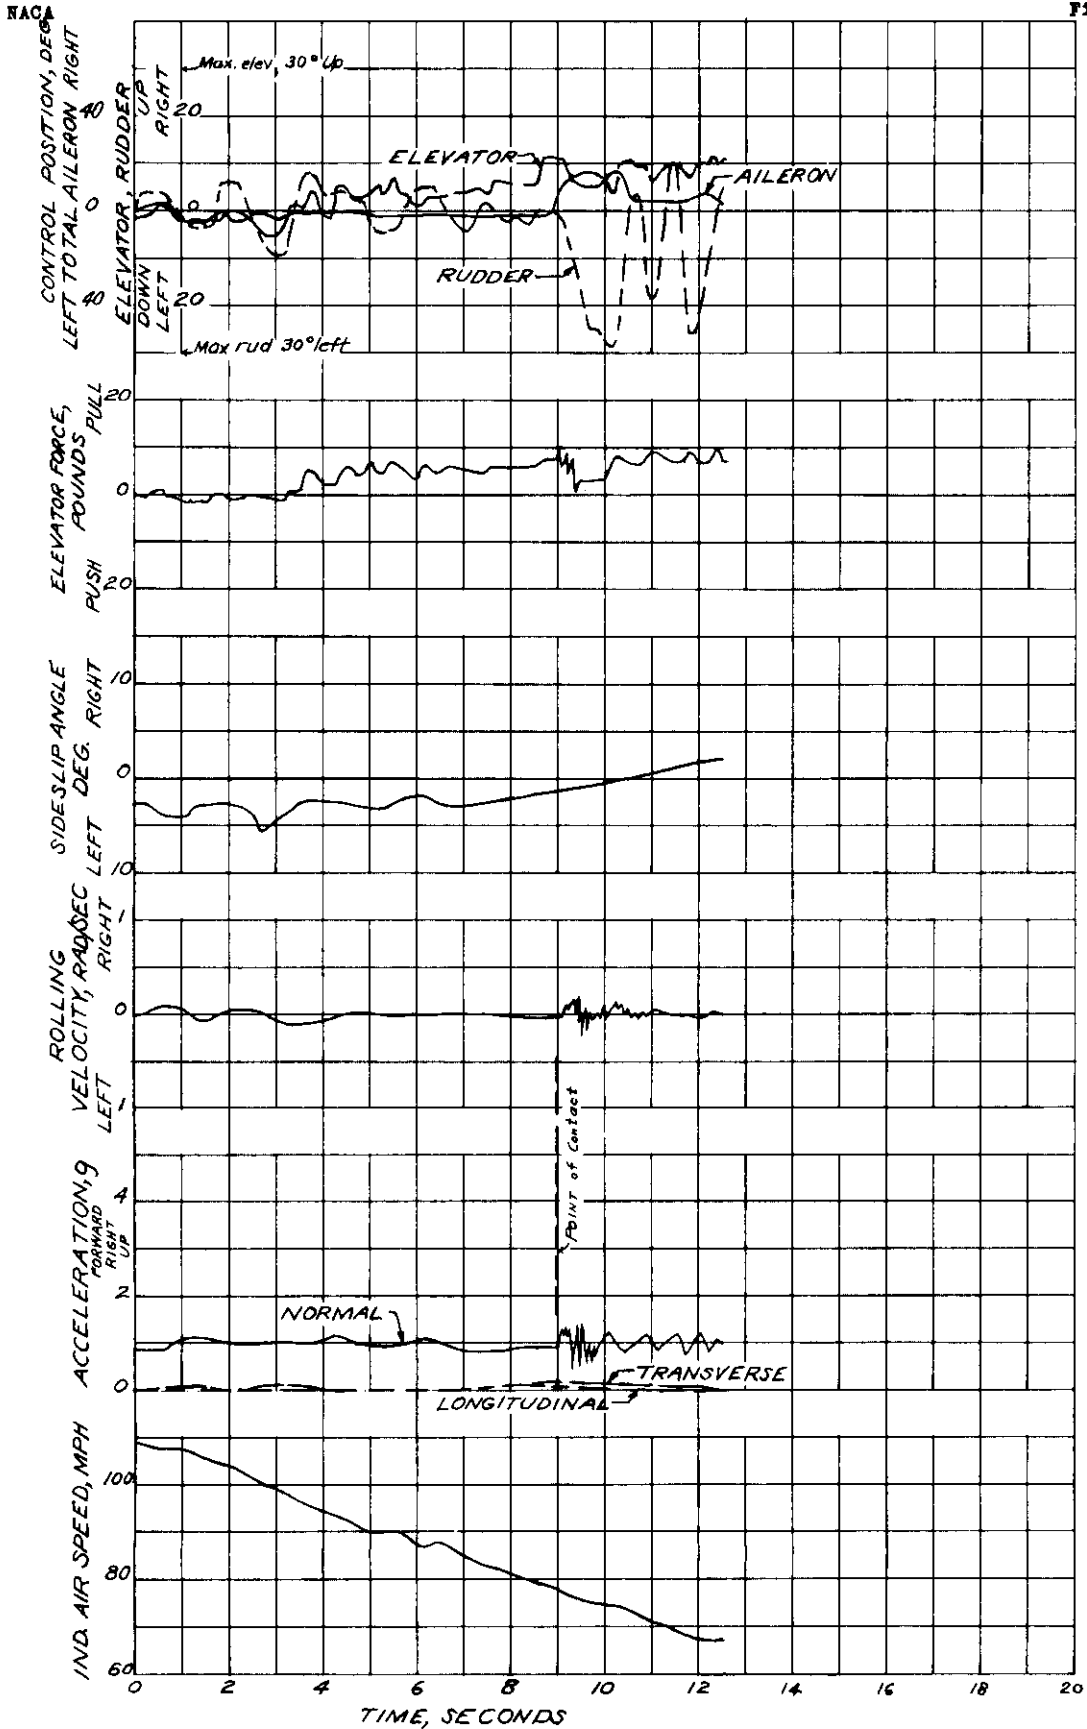
Figure 22. - Time history of a three-point landing (trim tab, 2.3° nose heavy). Note unsteadiness of airplane and controls caused by tail buffeting and instability in the approach. Supermarine Spitfire airplane.

wash at the tail caused by separation of the flow at the wing root was probably combined with that due to ground effect in the three-point landings. A time history of a three-point landing, shown in figure 22, illustrates the unsteadiness of the airplane and controls as the landing attitude was approached.

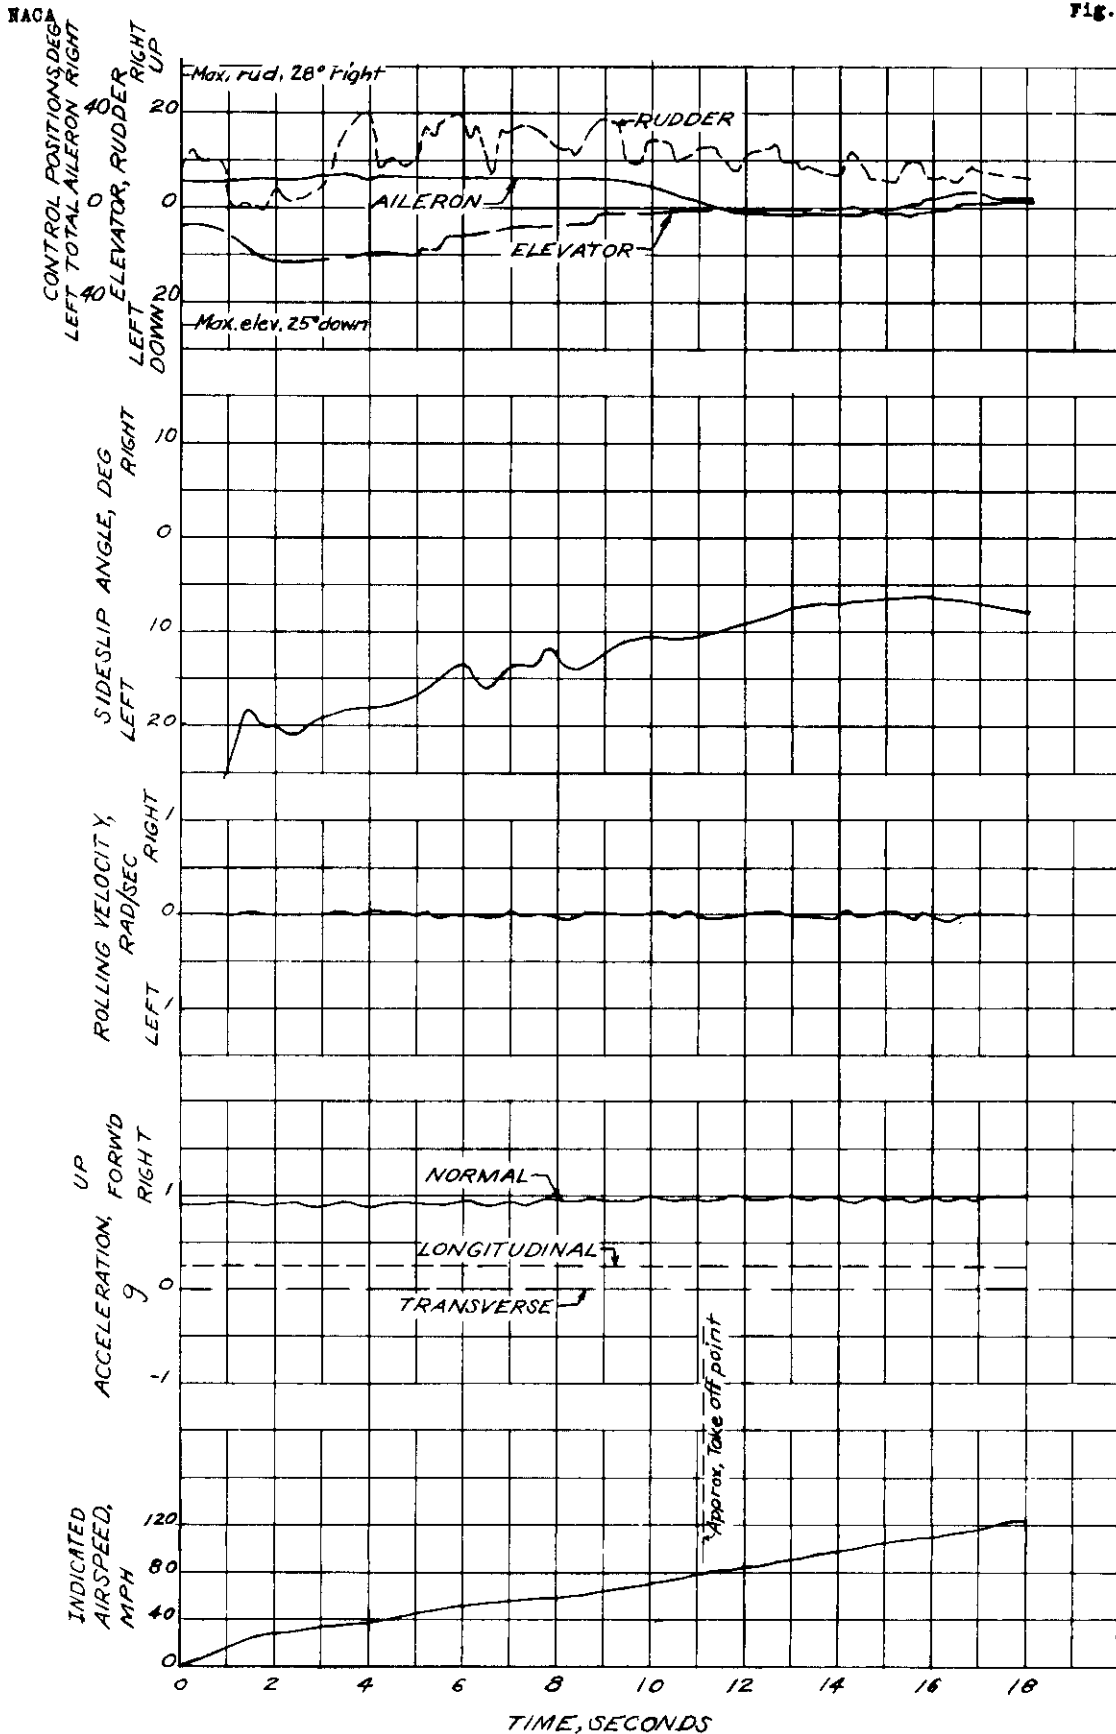
Figure 23. - Time history of a tail-high take-off made with 48 in. Hg manifold pressure. Supermarine Spitfire airplane.

The rudder control, in conjunction with the brakes, was sufficiently powerful to maintain directional control in take-off and landing. A time history of a take-off (fig. 23) shows that some rudder deflection was required to overcome a tendency to turn to the left. The rudder force required for this purpose, however, was observed to be relatively light.

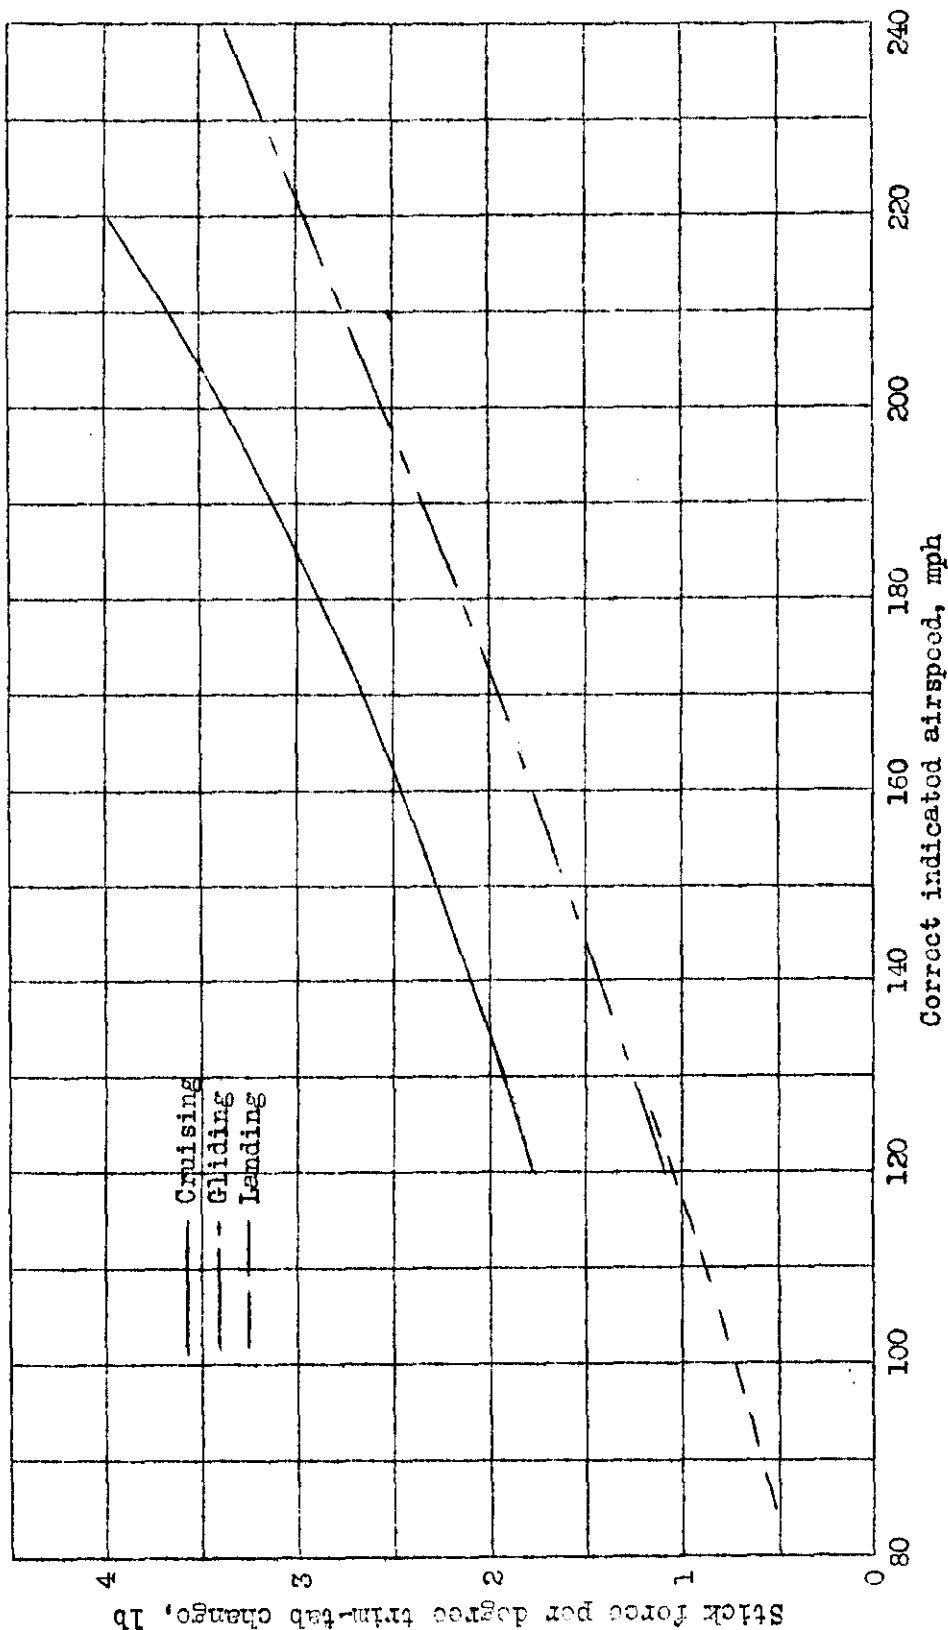
Figure 24.- Variation of power of the elevator trim tabs with indicated airspeed in the cruising, gliding, and landing conditions. Supermarine Spitfire airplane.

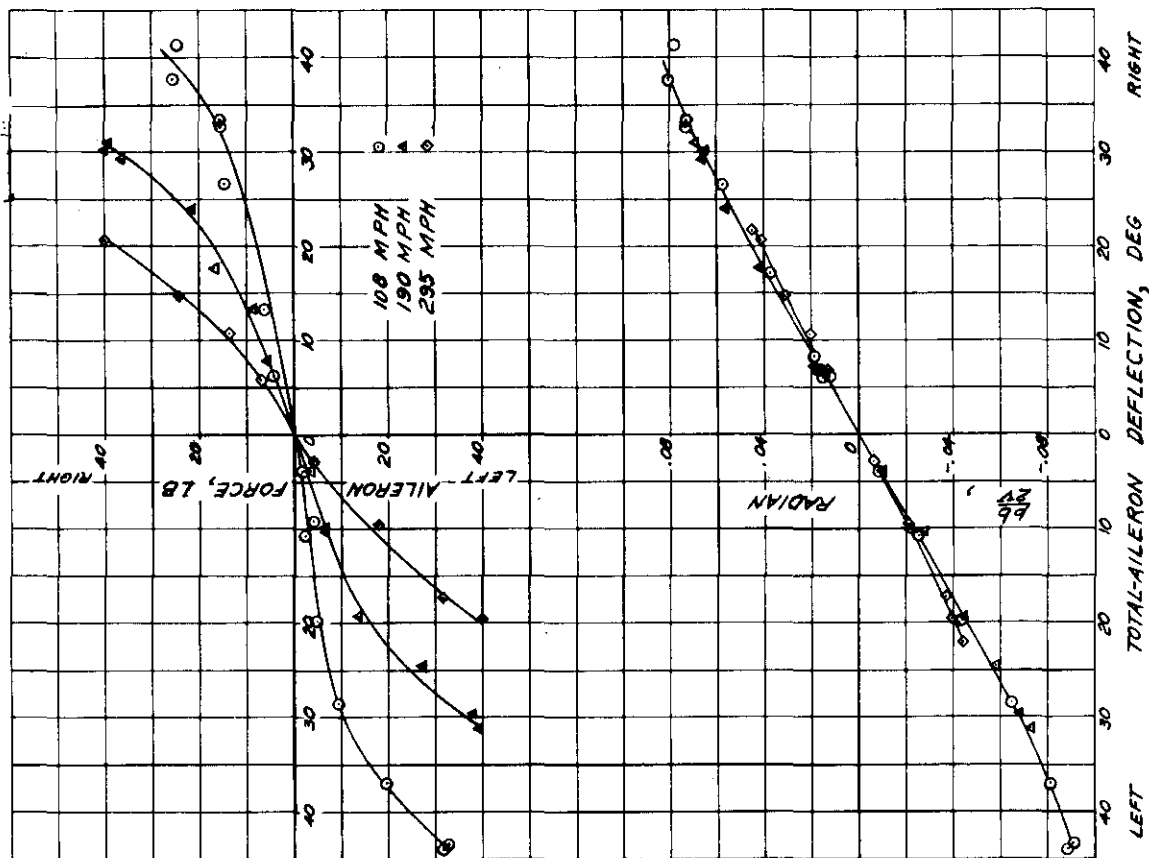
Figure 26. - Variation of aileron force and pb/2V with total aileron deflection in level flight (flaps up, gear up). Supermarine Spitfire airplane.

The results of these tests are presented in figures 25 to 28. Figure 25 shows the variation of $pb/2V$ and aileron force with total aileron deflection in the landing condition, and figure 26 gives these curves for level flight with flaps and gear up at three speeds. Total aileron deflection is defined as the sum of the deflections of the right and left ailerons. The quantity $pb/2V$ is the helix angle in radians described by the wing tip in a roll, where p is the rolling velocity in radians per second, b the wing span in feet, and V the true velocity in feet per second. A complete discussion of this criterion for aileron effectiveness is given in reference 3.

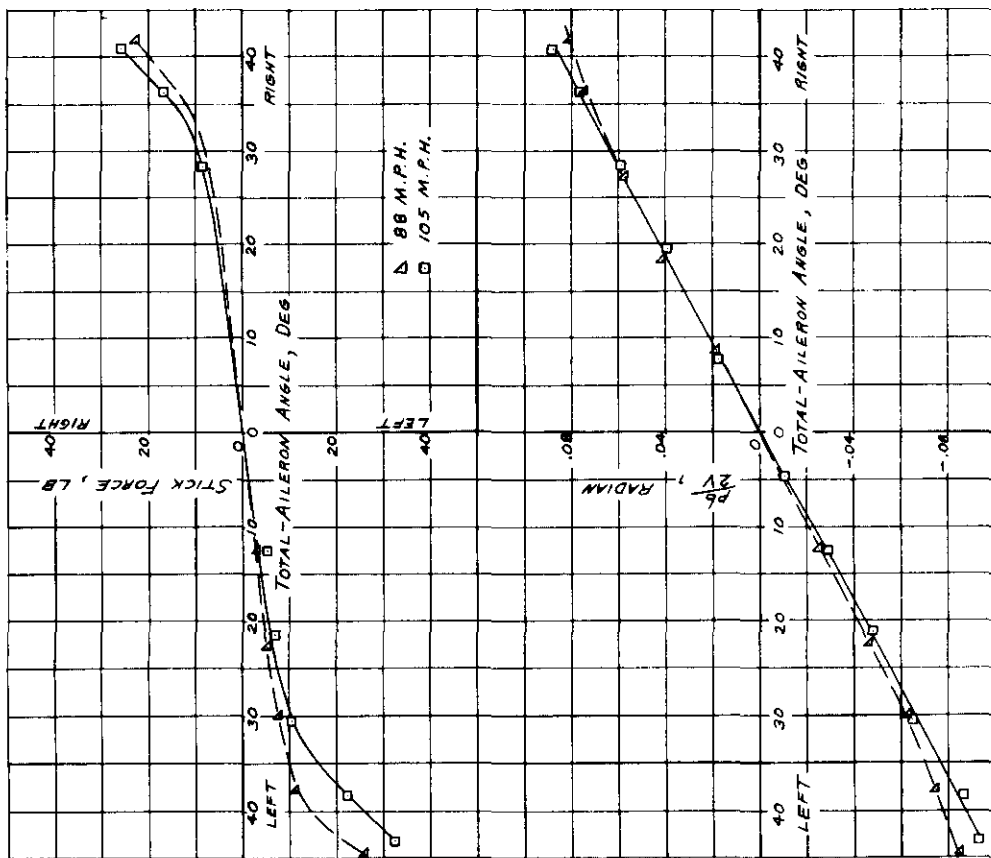
Figure 25. - Variation of aileron force and pb/2V with total aileron deflection in the landing condition (flaps down, gear down, power off). Supermarine Spitfire airplane.

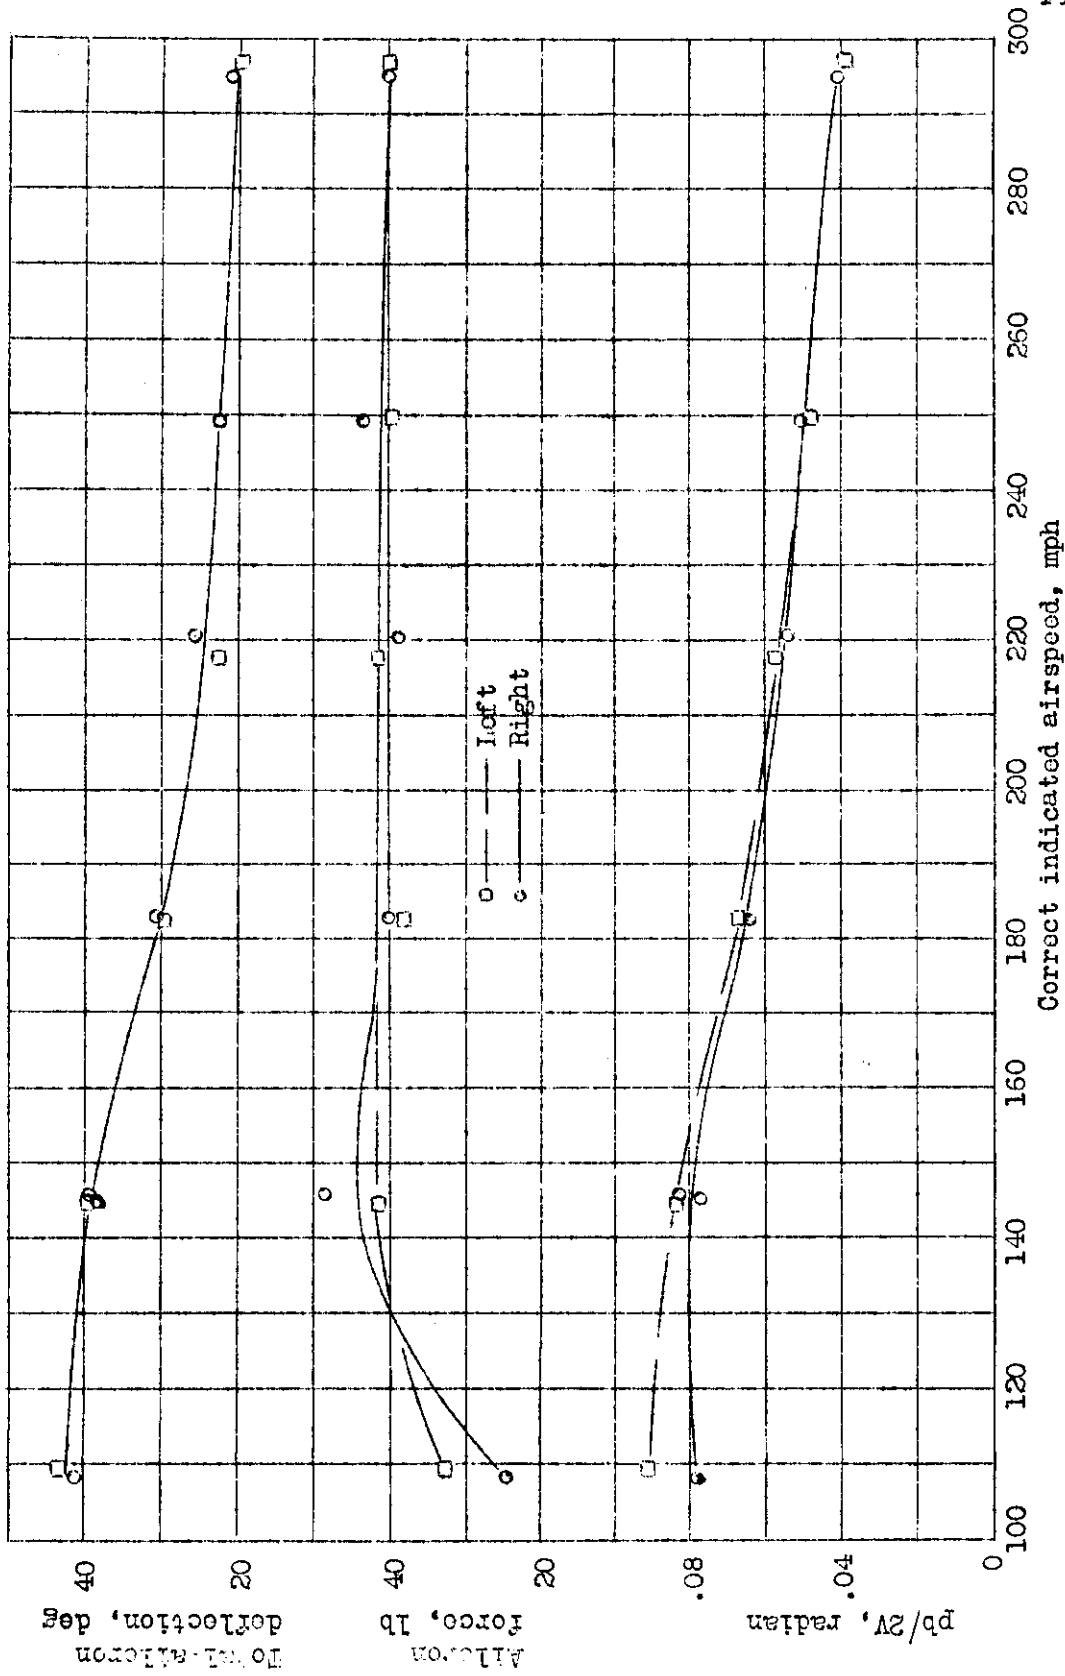
Fig. 27

Figure 27.- Variation of maximum obtainable aileron deflection, aileron force, and pb/2V with indicated airspeed in level flight (flaps up, gear up). Supermarine Spitfire airplane.
