NATIONAL ADVISORY COMMITTEE FOR AERONAUTICS

ADVANCE CONFIDENTIAL REPORT

MEASUREMENTS OF THE FLYING QUALITIES OF A
SUPERMARINE SPITFIRE VA AIRPLANE

By William H. Phillips and Joseph R. Vensel

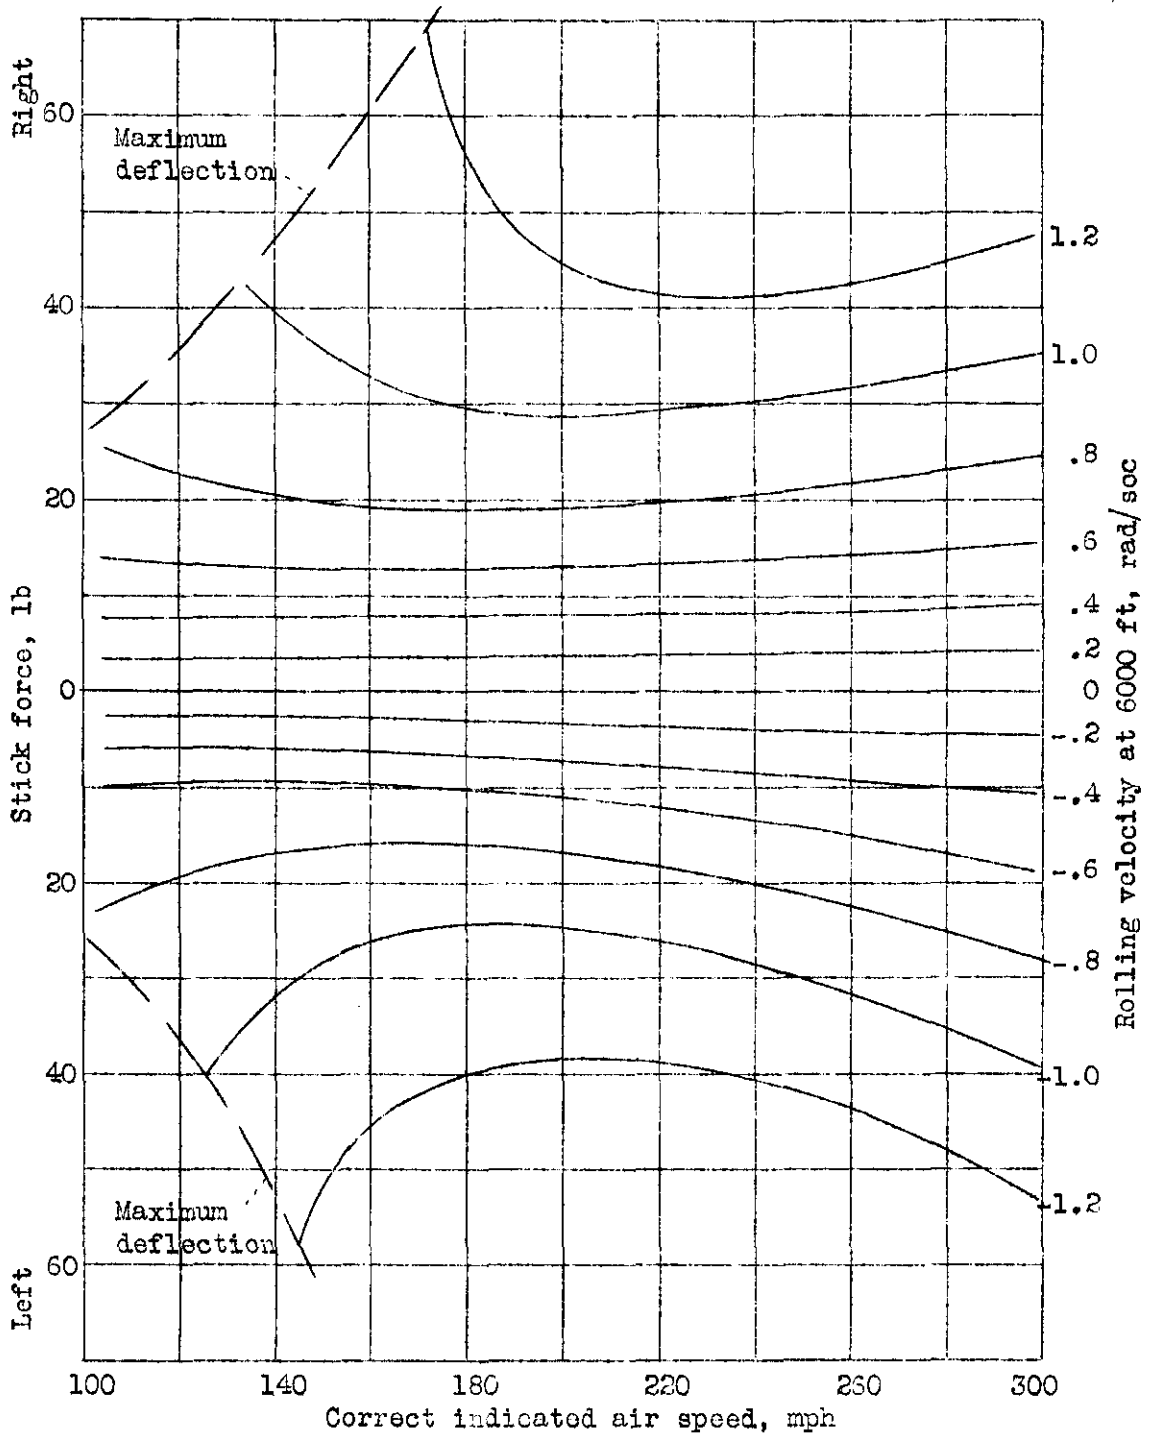
Figure 28.- Variation of aileron stick force with speed for different rolling velocities in level flight (flaps up, gear up). Supermarine Spitfire airplane.

The results of these tests are presented in figures 25 to 28. Figure 25 shows the variation of $pb/2V$ and aileron force with total aileron deflection in the landing condition, and figure 26 gives these curves for level flight with flaps and gear up at three speeds. Total aileron deflection is defined as the sum of the deflections of the right and left ailerons. The quantity $pb/2V$ is the helix angle in radians described by the wing tip in a roll, where p is the rolling velocity in radians per second, b the wing span in feet, and V the true velocity in feet per second. A complete discussion of this criterion for aileron effectiveness is given in reference 3.

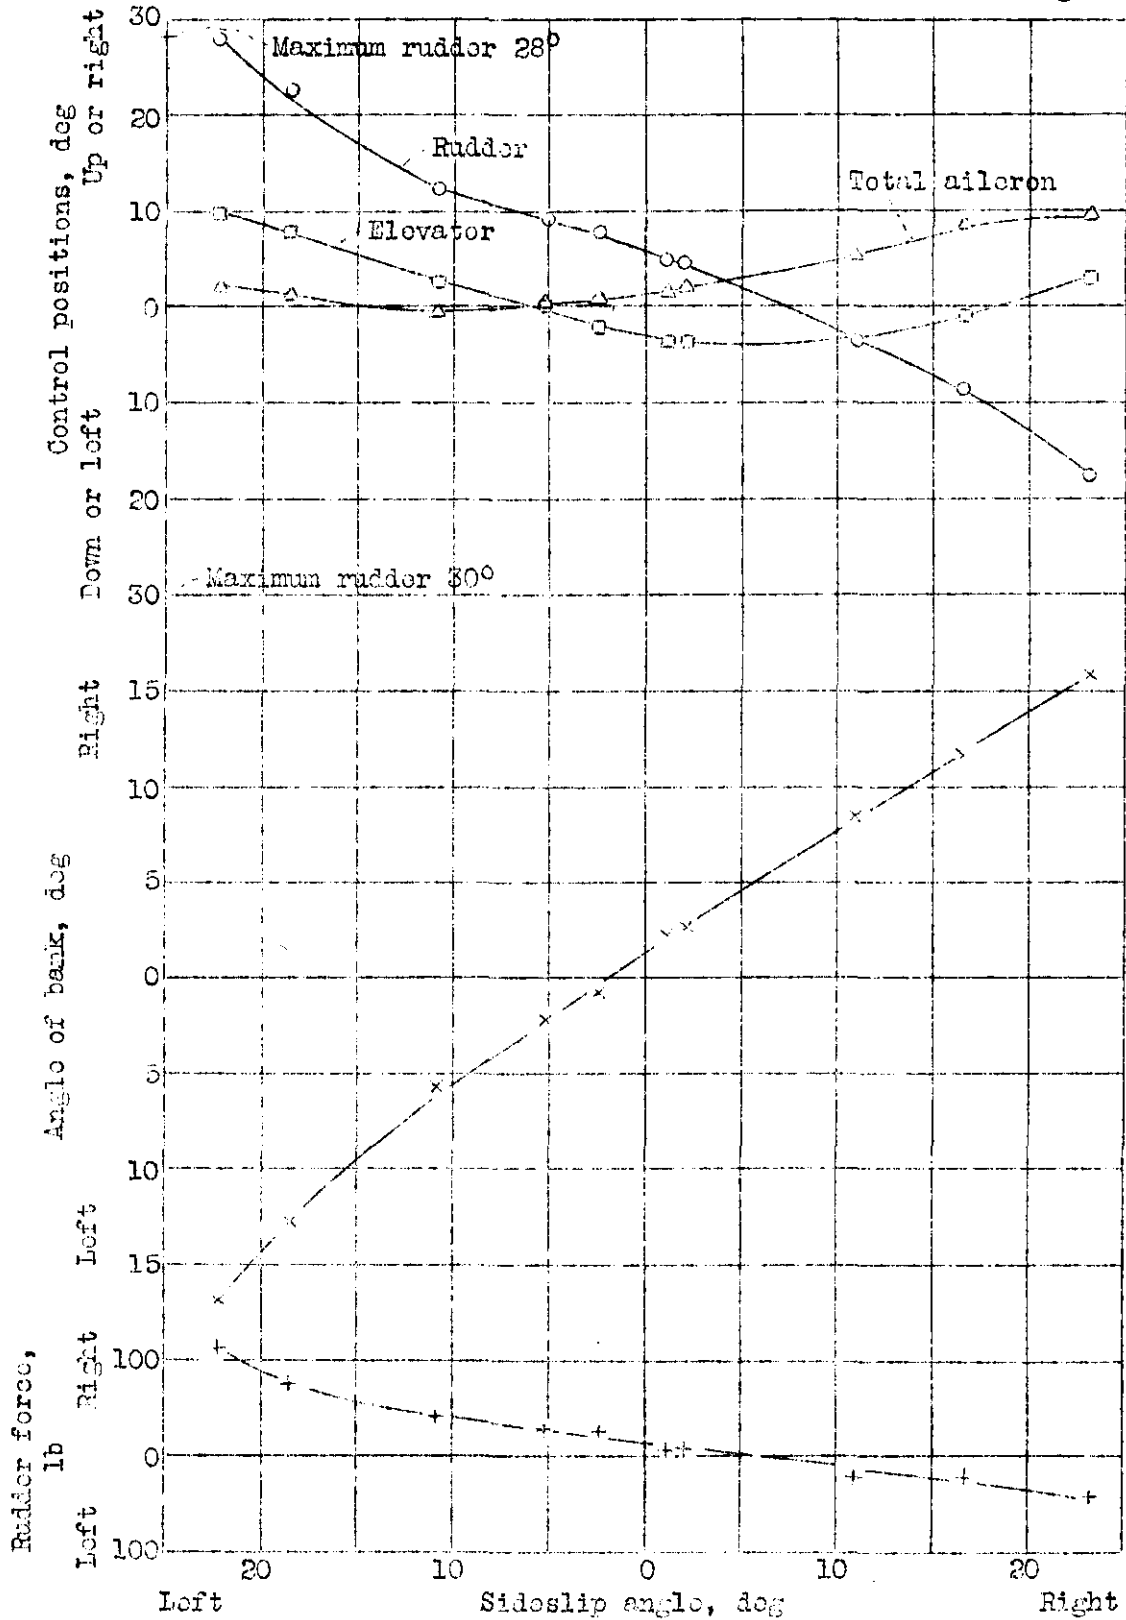
Figure 29.- Steady sideslip characteristics in the cruising condition (flaps up, gear up, power on) at 120 miles per hour. Supermarine Spitfire airplane.

Rolling moment due to sideslip.— The rolling moment due to sideslip of the Spitfire airplane was determined by recording the aileron angles required in steady sideslips. The results of these measurements are presented in figures 29 to 34, where the rudder, elevator and aileron angles, angle of bank, and rudder force are plotted as functions of the sideslip angle. The dihedral effect was stable in all conditions, with the exception that in left sideslips in the cruising condition the dihedral effect was practically neutral. The requirement of reference 1 was therefore met in all conditions except in left sideslips with power on.

angles of bank required to hold steady sideslips in the various flight conditions (figs. 29 to 34). The angles of bank were small at low speeds, but they increased rapidly with speed because the side force for a given sideslip angle varies approximately as the square of the speed. The Spitfire showed a slightly smaller side-force gradient than any other pursuit-type airplane tested previously. A larger side-force gradient would seem to be desirable because the pilot would find it easier to maintain unyawed flight if a large angle of bank were required to sideslip.

Pitching moment due to sideslip.- The pitching moment due to sideslip is shown by the variation of elevator angle with angle of sideslip in the steady sideslip measurements (figs. 29 to 33) and by the variation of normal acceleration with rudder angle in the rudder kicks (figs. 35 and 36). The Spitfire showed a tendency to pitch down both in left and right sideslips. In power-on flight, this airplane failed to meet the requirement (reference 1) that less than 1° change in elevator angle should accompany 5° deflection of rudder. As shown on figure 29, left sideslip occurred in the trim condition with wings level, and at this sideslip angle the elevator angle increased approximately linearly with the left sideslip angle. The static longitudinal-stability measurements indicated that the sideslip increased as the speed was reduced until it reached about 10° at the stall. The elevator angle required for this sideslip completely overshadowed any elevator motion required to change speed in unyawed flight. The increased up-elevator angles encountered at low speeds in the cruising condition therefore do not represent static longitudinal stability. It is doubtful that this type of variation of elevator angle with speed is helpful to the pilot in maintaining a fixed trim speed. Furthermore, the static longitudinal-stability characteristics recorded by two pilots might disagree considerably, because slight errors in holding the wings level would result in appreciable differences in sideslip angle.

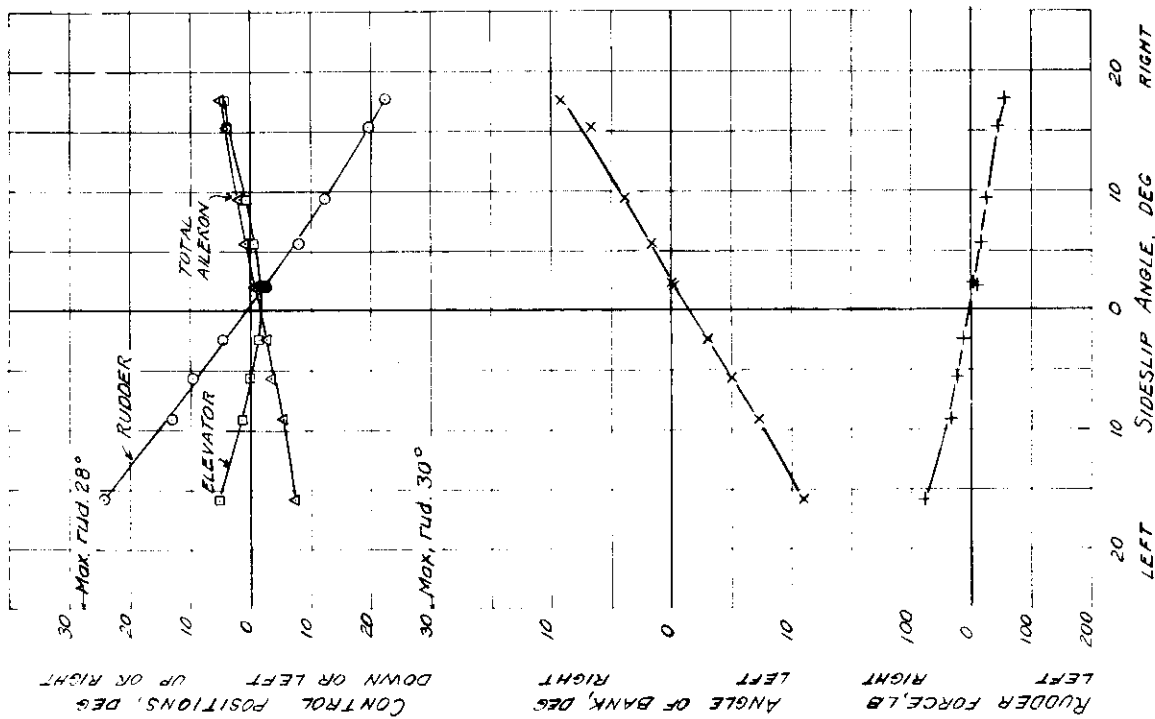
Figure 33. - Steady sideslip characteristics in the landing condition (flaps down, gear down, power off) at 124 miles per hour. Supermarine Spitfire airplane.

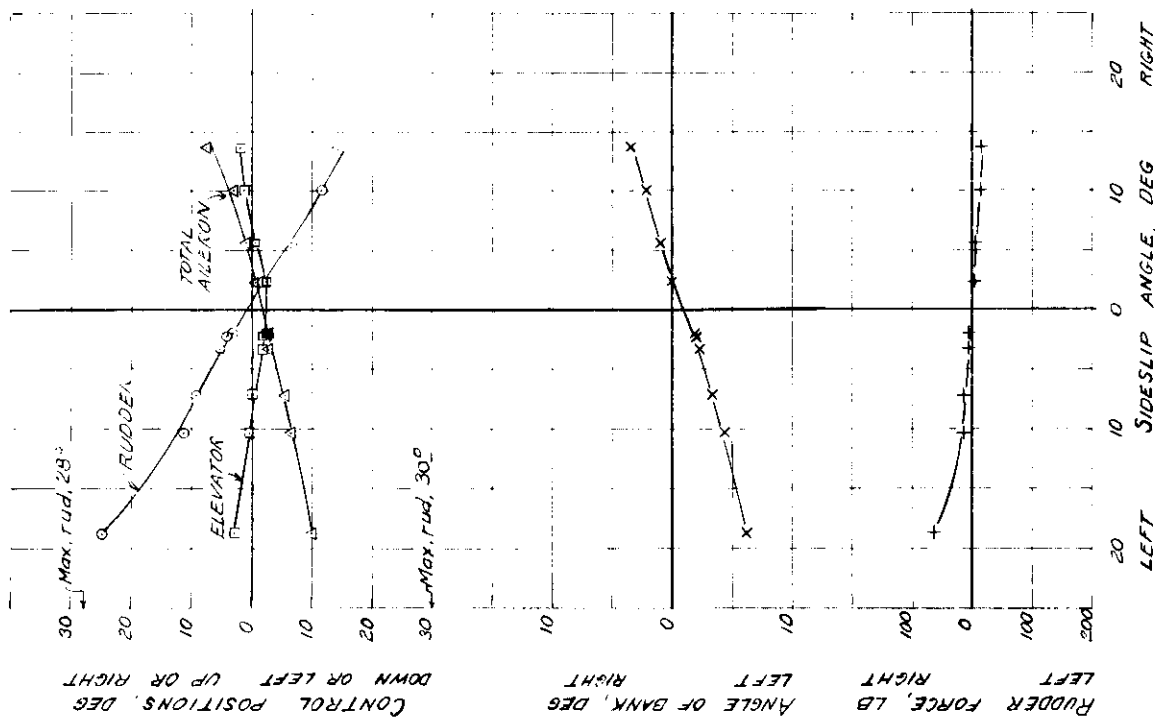
Figure 32. - Steady sideslip characteristics in the landing condition (flaps down, gear down, power off) at 95 miles per hour. Supermarine Spitfire airplane.

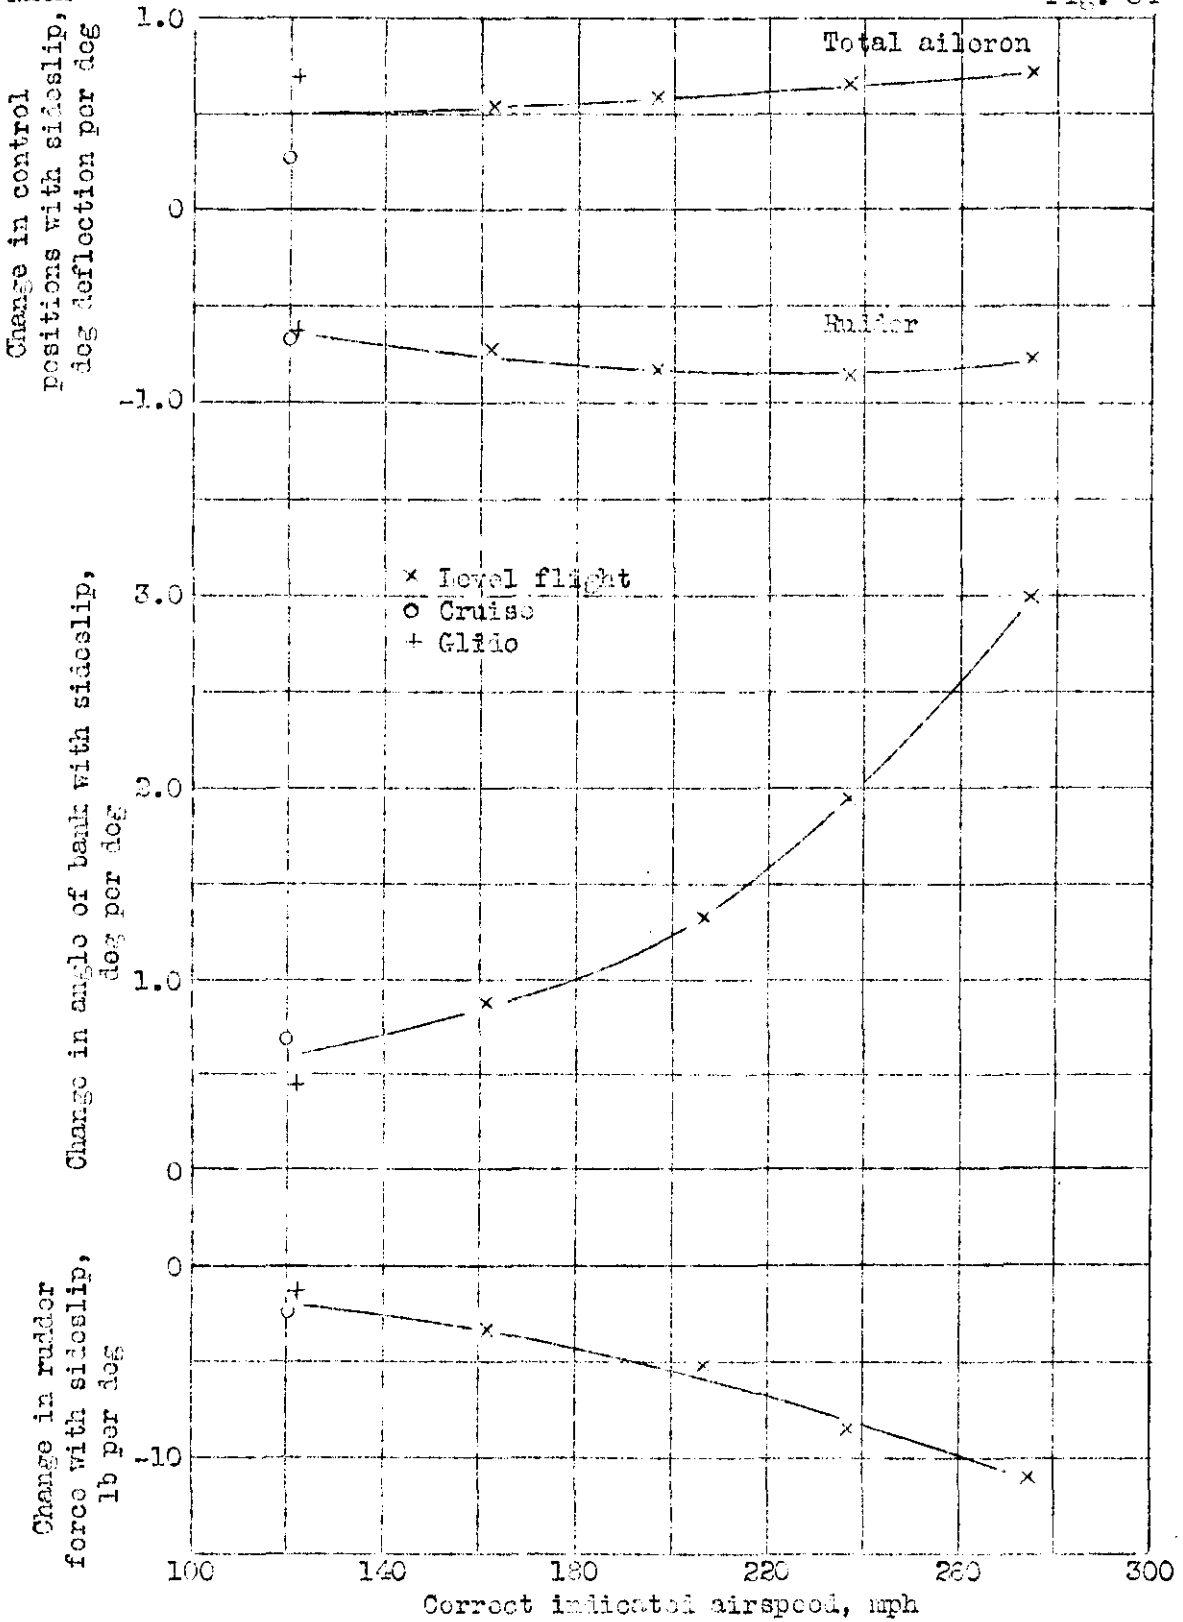
Figure 34.- Steady sideslip characteristics for small rudder deflections at various speeds in level flight with flaps and gear up, hood closed. Supermarine Spitfire airplane.

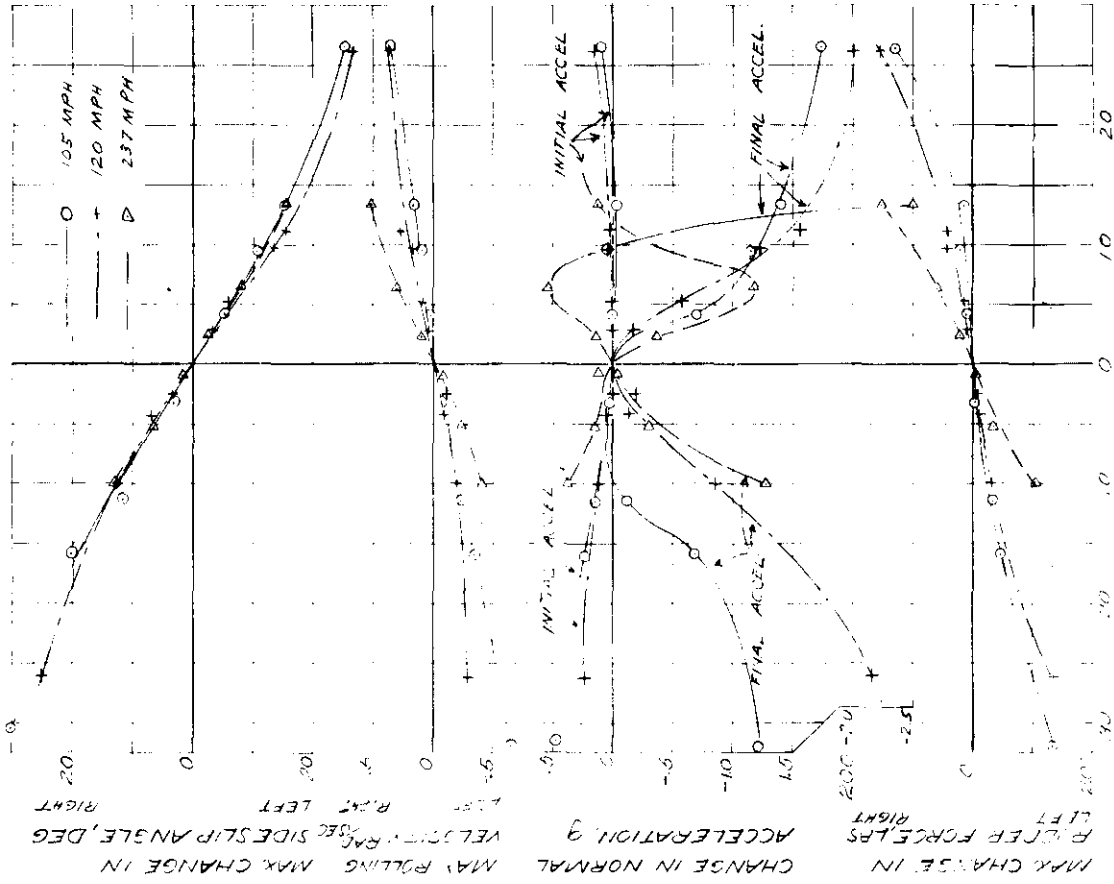
Figure 35. - Variation of maximum change in sideslip angle, rolling velocity, change in normal acceleration, and change in rudder force, with rudder deflection in abrupt rudder kicks in the landing condition. Supermarine Spitfire airplane.

A further indication of the rolling moment due to sideslip is given by the rolling velocities caused by abrupt deflections of the rudder (figs. 35 and 36). The airplane always rolled in the correct direction. The rolling moment due to yawing velocity is combined with that due to sideslip in these tests.

The initial values of rudder force in rudder kicks, plotted in figures 35 and 36, show that the rudder was desirably light. The floating tendency of the rudder caused the pedal force to drop to about one-third of its initial value after the sideslip had built up. No reversal of rudder force ever occurred, however. The requirement of reference 1, which states that left rudder force should always be required for left rudder deflections and right rudder force for right rudder deflections, was therefore satisfied.

The violence of the pitching motions of the airplane in rudder kicks is shown by the variation of normal acceleration with rudder angle (figs. 35 and 36). Because the large accelerations made it difficult for the pilot to hold the elevator angle constant, the normal acceleration plotted on these figures may be partly the result of elevator motion. Nevertheless, the plotted values give a qualitative idea of the pitching motions caused by rudder

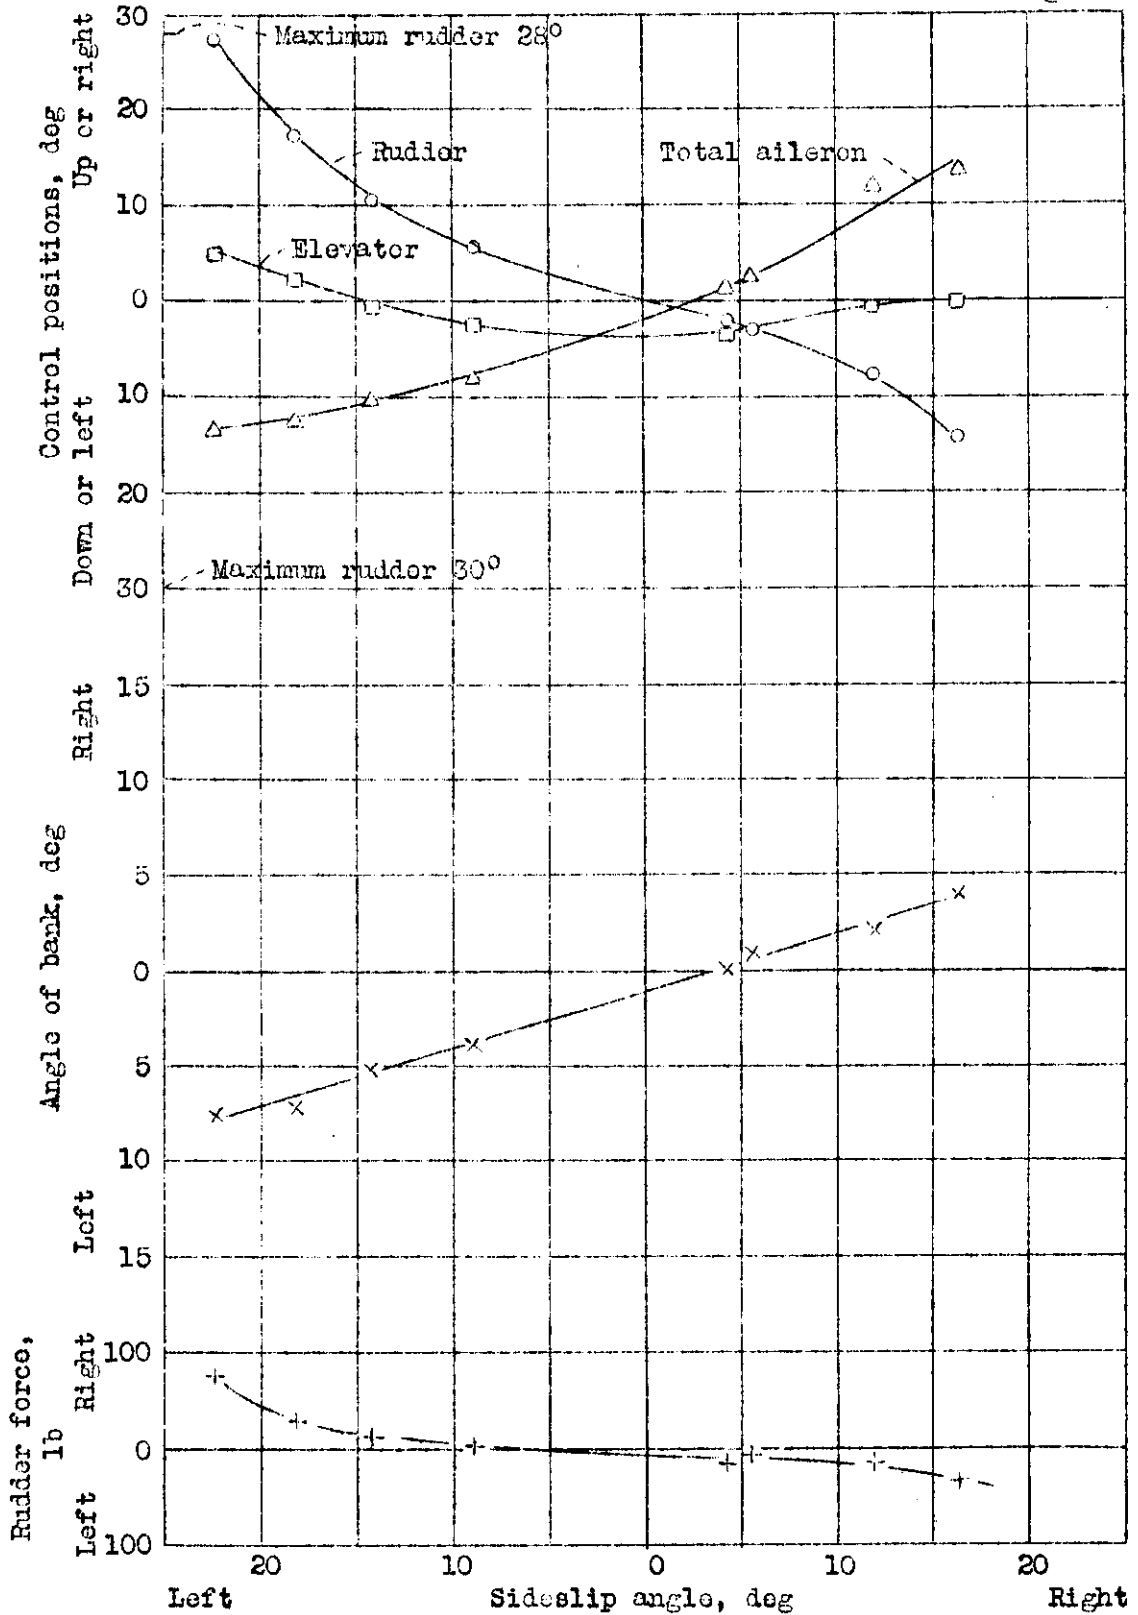
Figure 30.- Steady sideslip characteristics in the gliding condition (flaps up, gear up, power off) at 107 miles per hour. Supermarine Spitfire airplane.

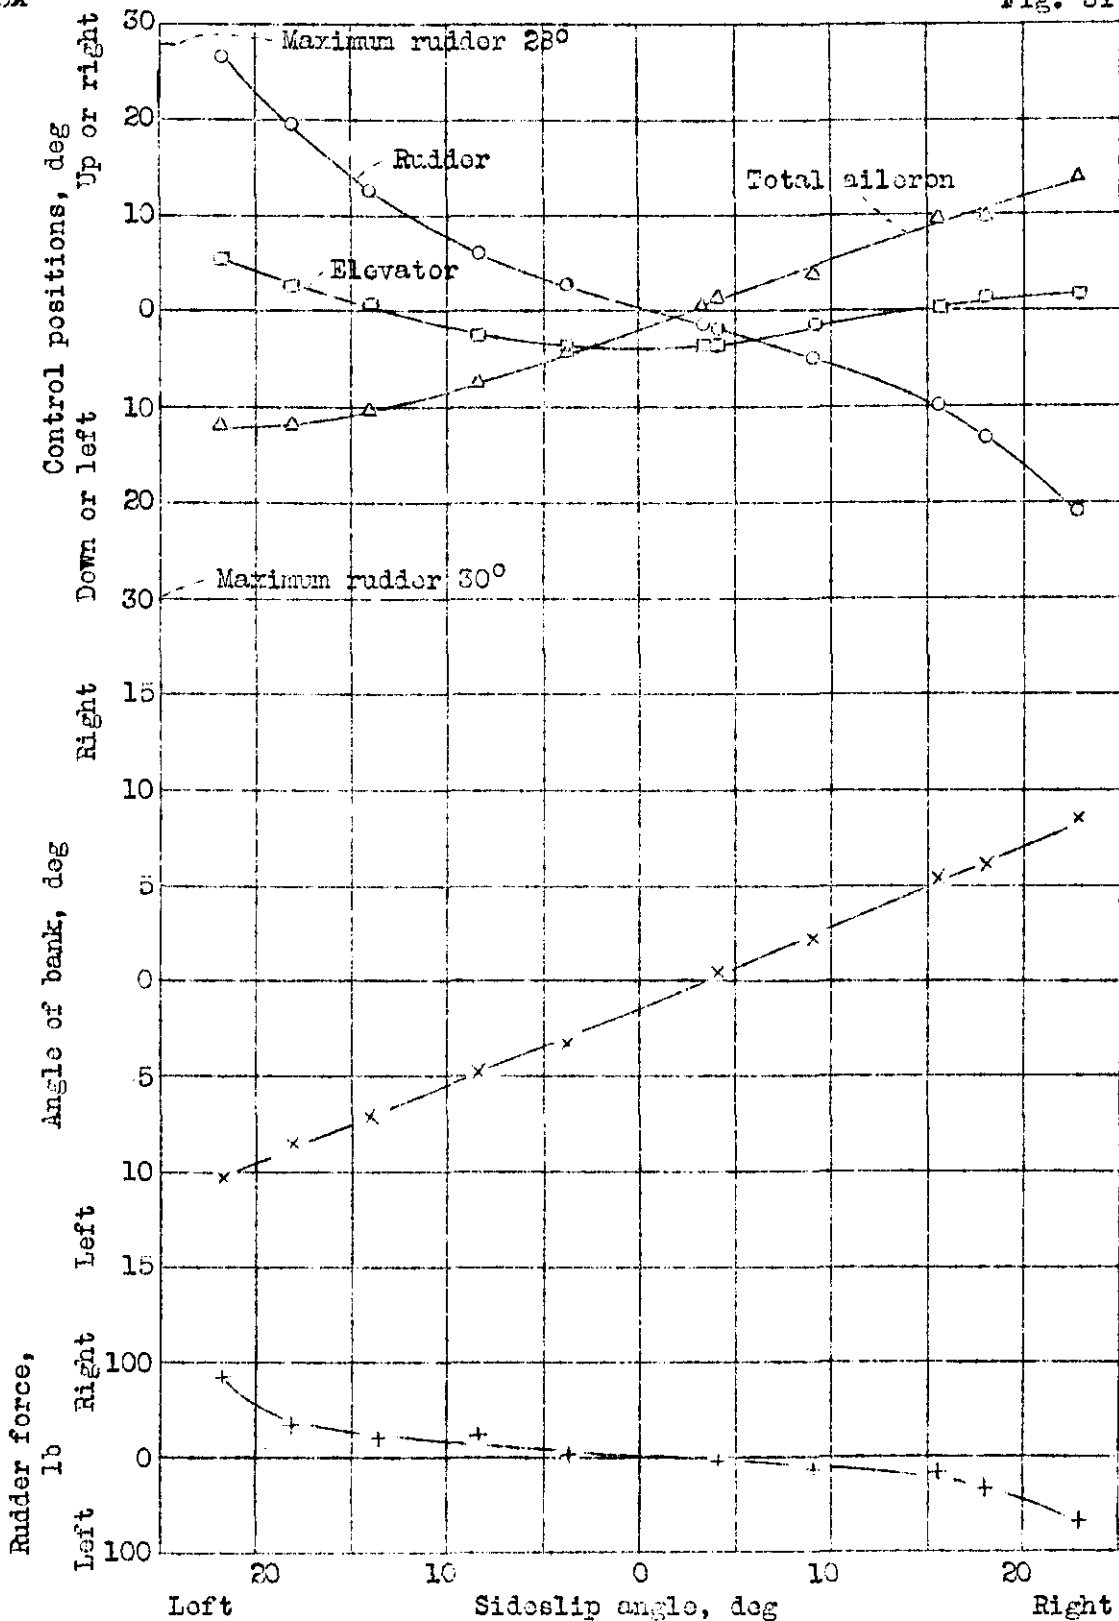
Figure 31.- Steady sideslip characteristics in the gliding condition (flaps up, gear up, power off) at 122 miles per hour. Supermarine Spitfire airplane.
